NANO-REGION

PROOF-OF-CONCEPT EXPERIMENT REPORT

INVESTIGATION ON FAILURE WITH COMMERCIAL CHIPS BASED ANALYSIS

Istituto Officina dei Materiali - CNR-IOM

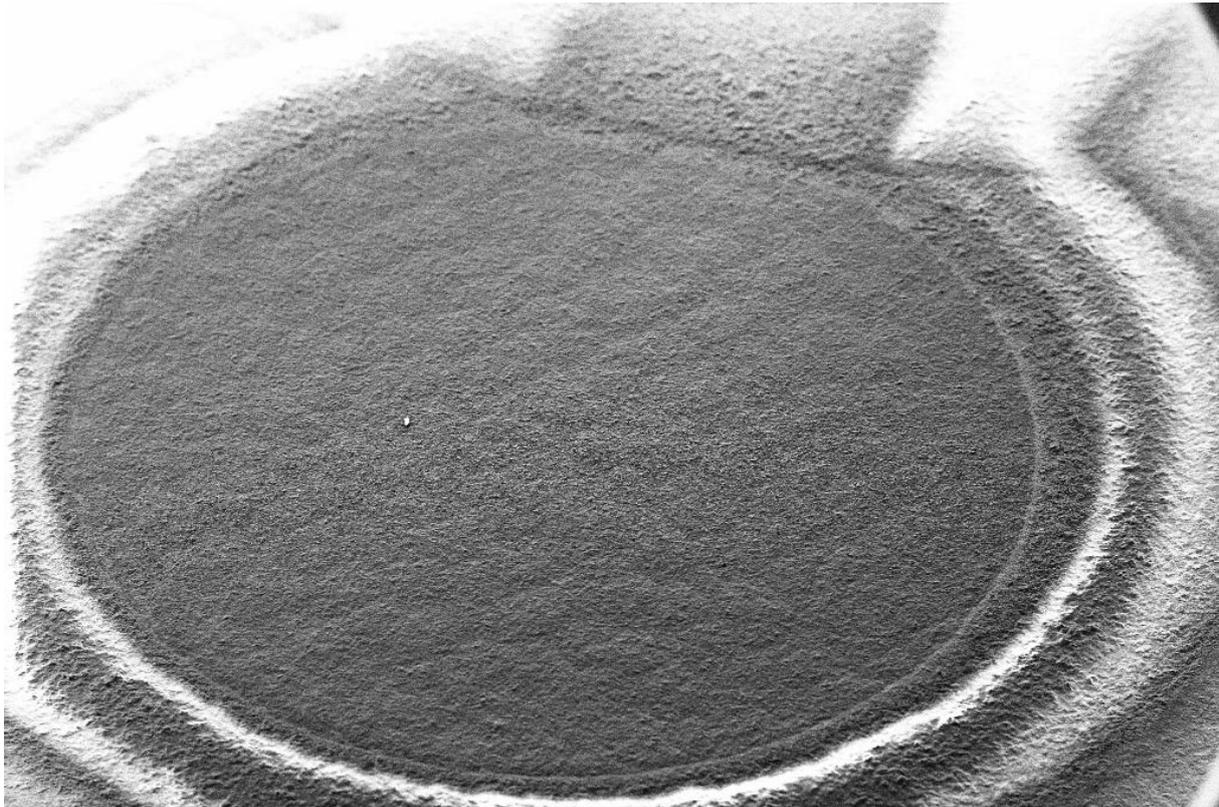
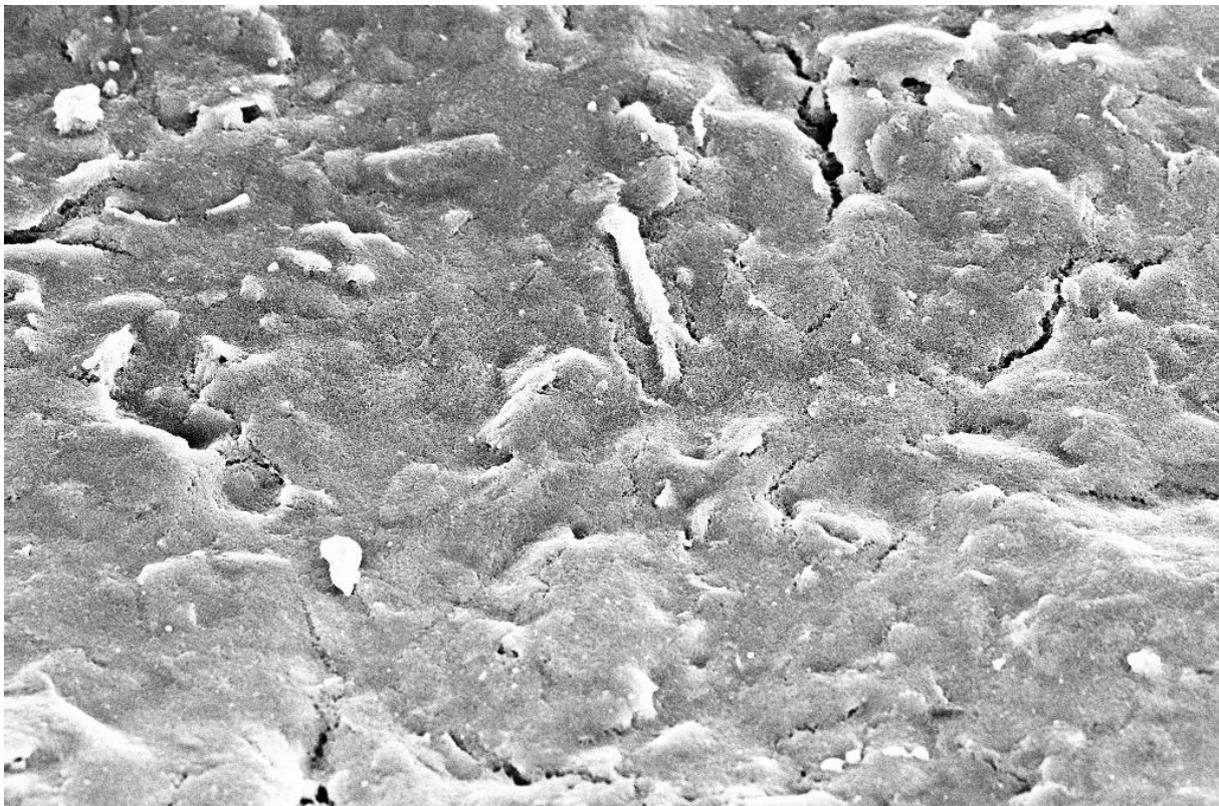
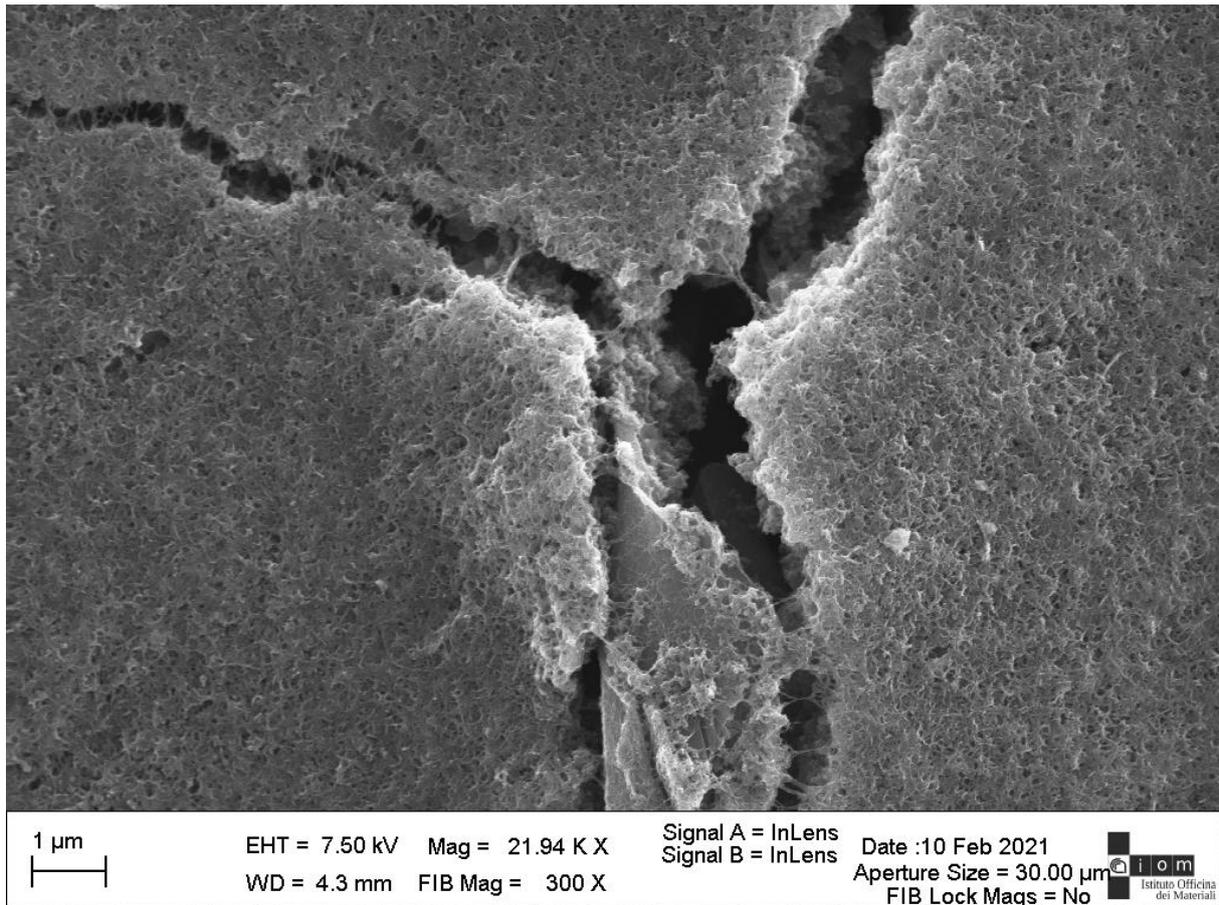
In the next picture is described the details of the CNT's electrodes collect at high magnification. No significant differences can be seen between at this level on the CNT's morphology.

Figure 1 Sem images of the central electrode of the clean not used chip.

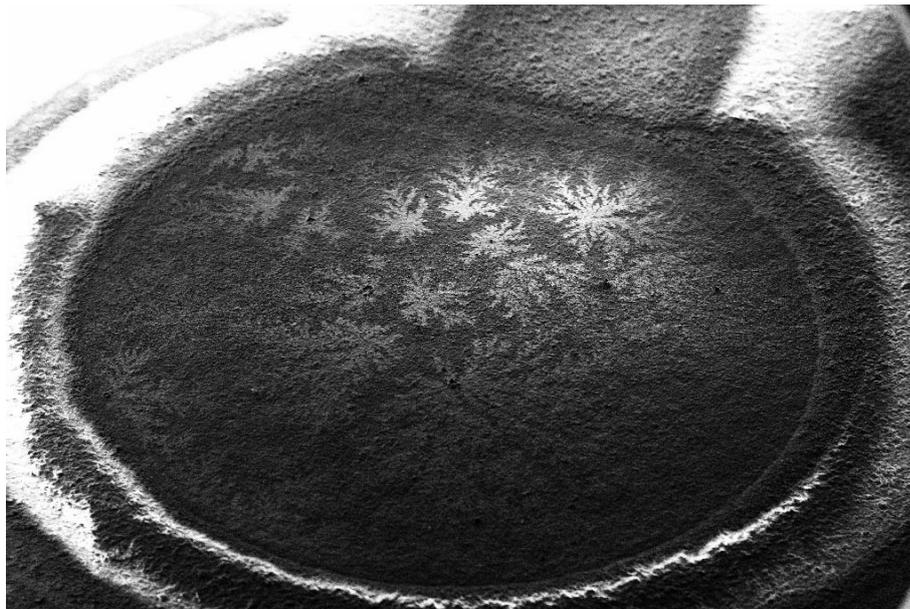
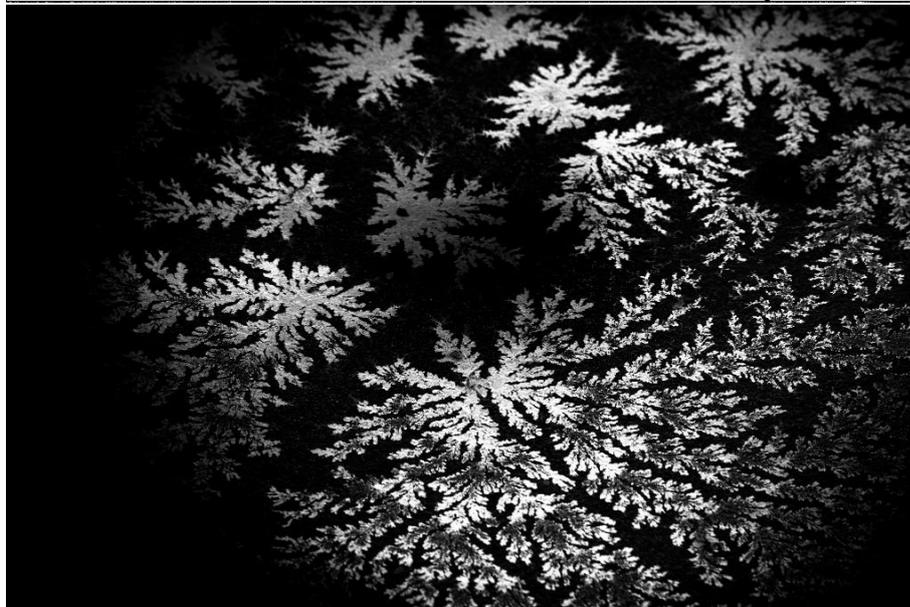
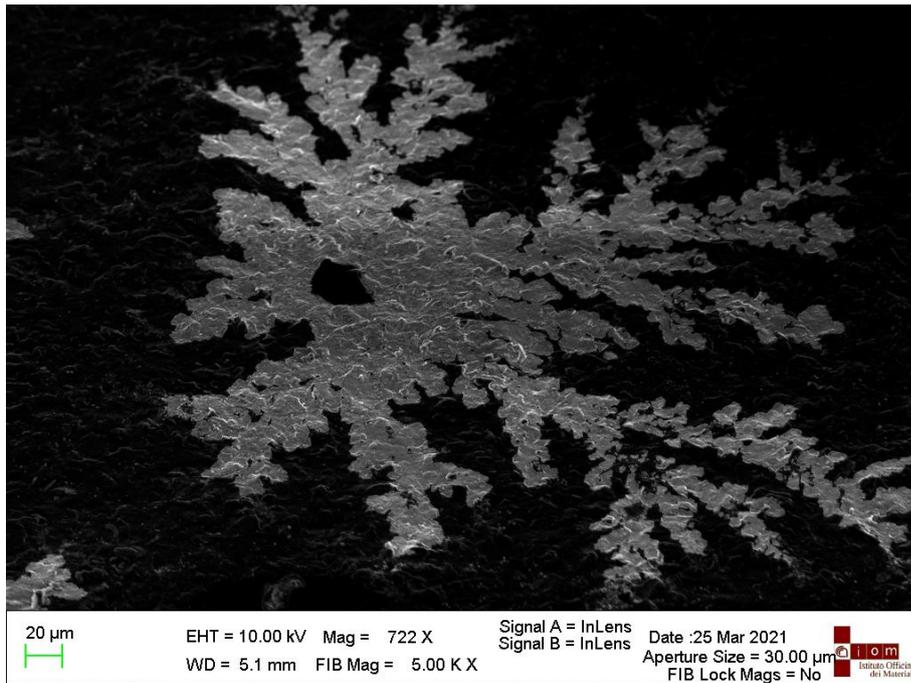
On the contrary, lower magnification images show more interesting features on the central electrodes, in particular when IL detector is employed. Differently from the clean (unused) chip, the used ones show the evidence of crystal-like growth atop of the CNT's electrodes; the amount and the size are different on each substrate, and the chip n.3 look pretty completely coated by the thin layer of crystal. The thickness of this film is not easy to be estimated because of not uniform coverage, but can be evaluated in few hundred of nanometers.

Figure 2 Sem images of the contaminated chips. The crystalline structures are included in the entire surface of the chip.

The salt contaminants seem to be mostly NaCl residuals, probably included during the functionalisation procedures; accurate rinse may solve the problem.

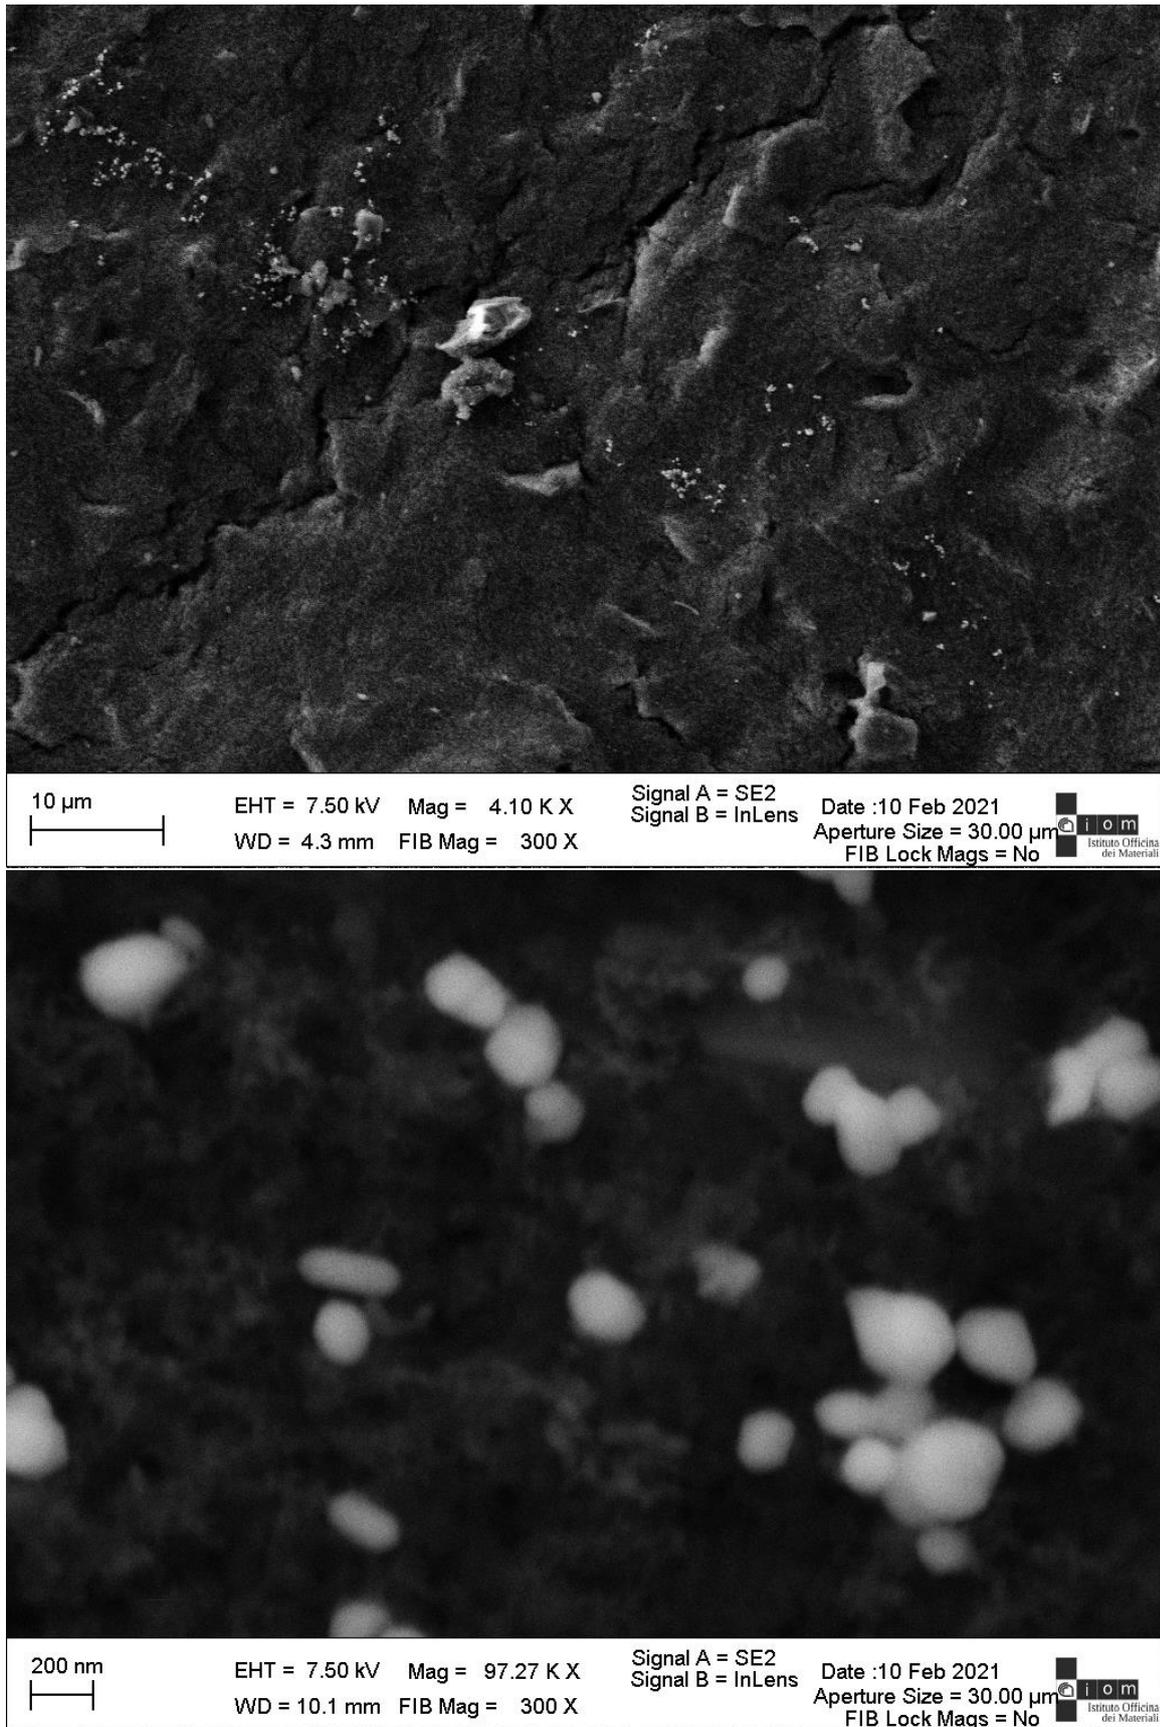
A second kind of contaminants are also detected on the electrodes, and they look like bright nano particles; they seem to be more concentrated close to the edge of the electrodes, while in the middle region they are not present.

Figure 3 Nanoparticles individuated around the electrode edge.

It was not possible to trace the origin of the other contaminant as the size and concentration of these particles is too low.

The rest of contaminants include also paint particles; the company can evaluate an addition procedure for the cleaning of the chips, since we cannot evaluate the effects of these particles on the functionalisation procedure.

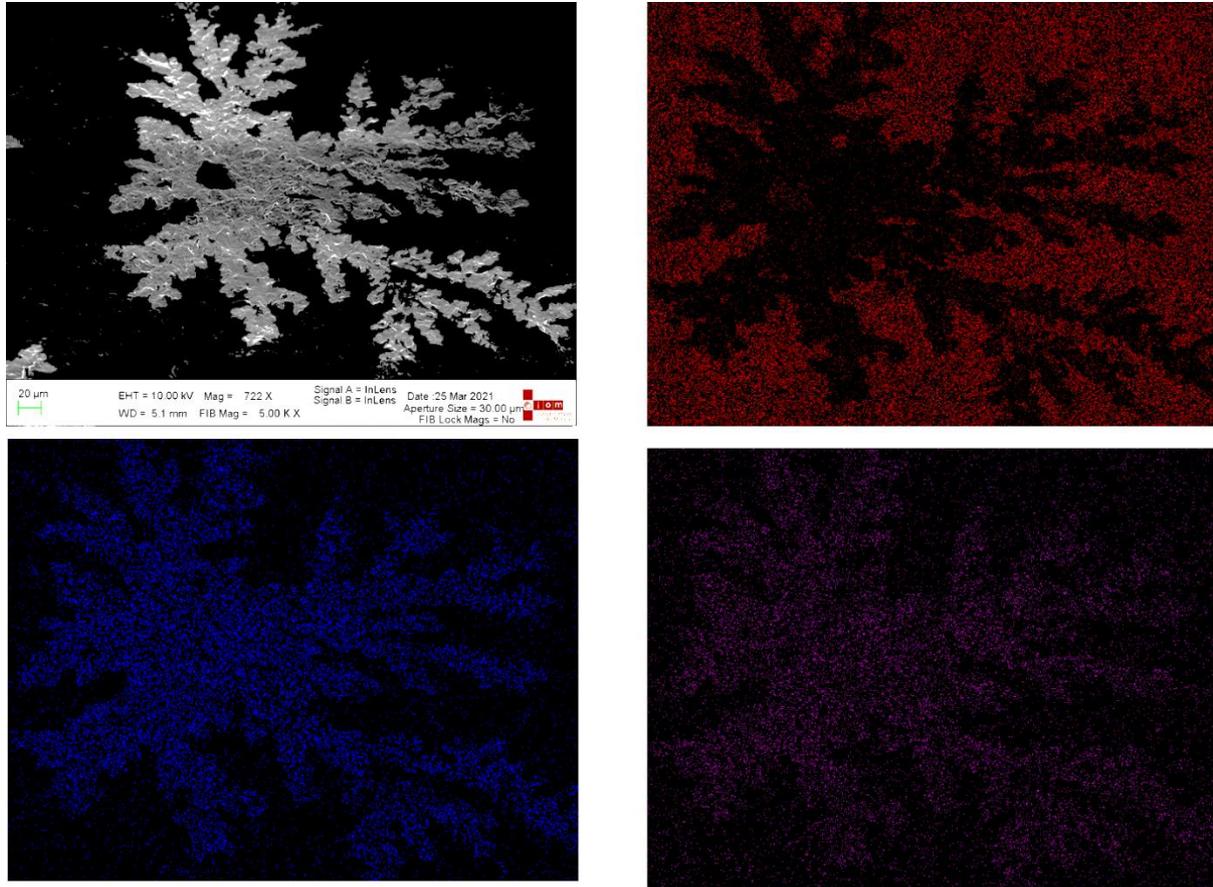
From the EDS analysis, as clearly visible from the maps and the spectra, the material forming the crystal-like structures can be identified in NaCl. We suppose the origin of it can be traced in not suitable or sufficient rinse after the deposition of the sample solution on the chip electrode.

Figure 4 Analysis of the crystalline structures on the central electrode: SEM image, C map, Cl map, Na map.

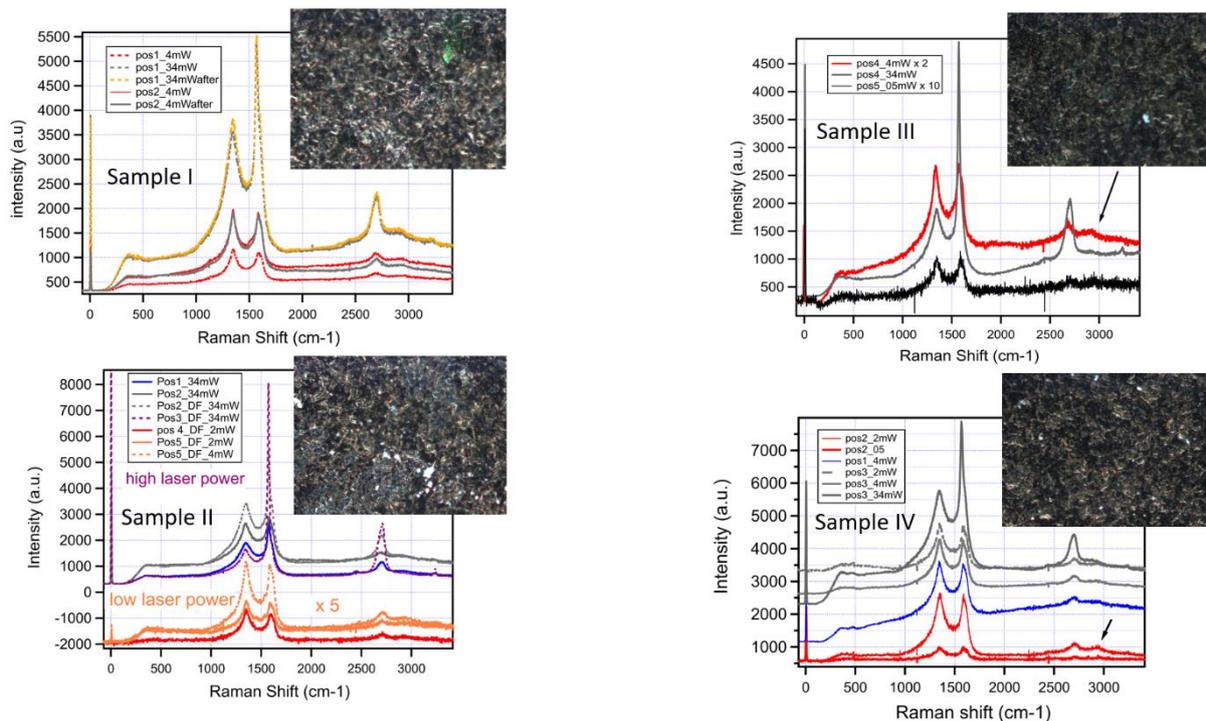
Figure 5

The figure 5 shows the Raman spectra acquired on a CNT covered region. The number of the samples corresponds with the number marked on each sample. Sample I was marked also with an asterisk (*).

The spectra of all the samples appear similar.

The spectra taken at low power show two peaks at 1350cm^{-1} and 1575cm^{-1} which correspond the D and G bands. Typically, in MW-CNT these two peaks show the same intensity.

A weak peak at 2700cm^{-1} , known as the 2D peak is also observed, while a weaker shoulder at 2930cm^{-1} is also observed at low power that corresponds to the D+G peak.

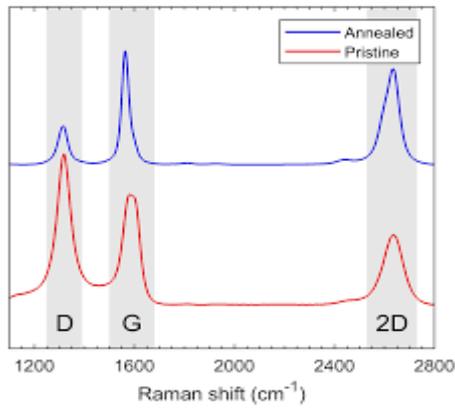
Figure 6

At higher power the spectra change and the G line becomes more intense and thinner, and some measurement, like in sample IV, pos3 34mW the splitting in G- and G+ can also be observed. These spectra are typical of SW-CNT, although the mechanism by which higher energy should trigger the formation of SWCNT was not investigated.

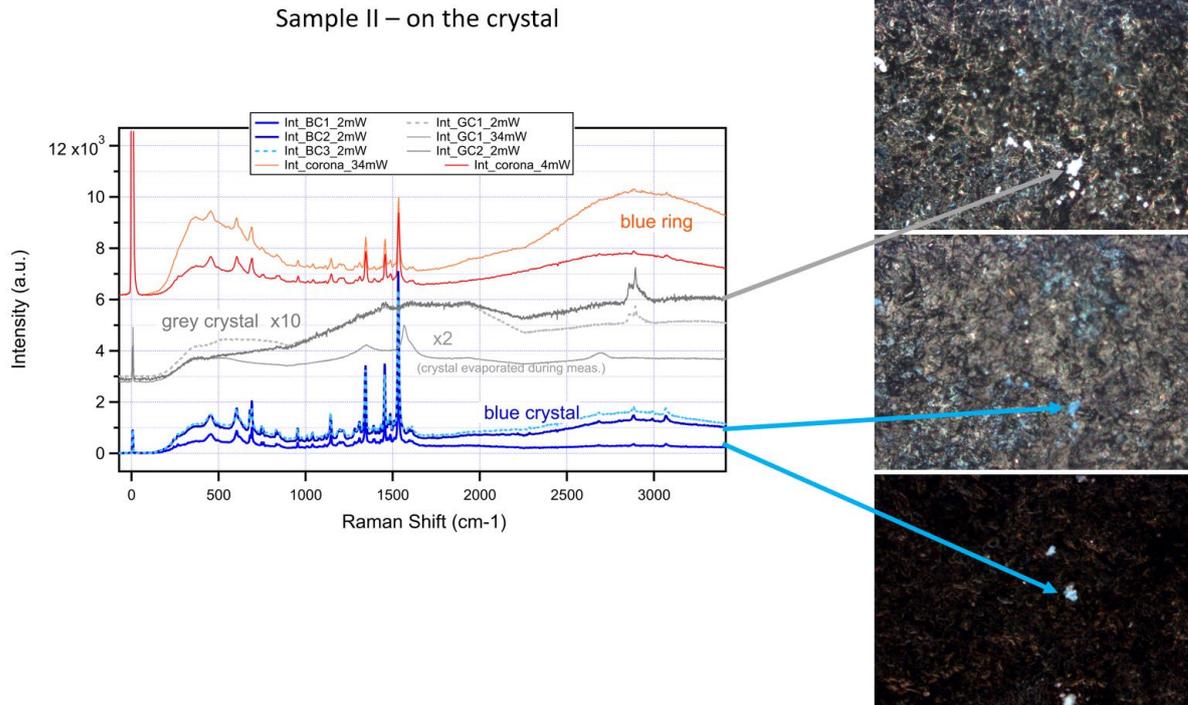
Figure 8

The silver defects show a broad luminescence, quite difficult to interpret without further information, and a typical feature at 2850 cm^{-1} that cannot be related to the CNT (grey spectra in figure 4). This feature disappears after high power illumination and the Raman signature of the CNT below can be observed.

The “blue” defects have a very well-defined Raman signature (blue spectra in figure 4) that can be identified in the Raman spectra of the blue macroscopic ring that defines the active area of the sensor. Therefore, we conclude that these impurities originated during the sensor manufacturing.
