### NANO-REGION

## PROOF-OF-CONCEPT EXPERIMENT REPORT INVESTIGATION ON POLYMERIC TEETH DEFECTS

**Received sample:** stock of artificial teeth

**Main aim of the proposal:** investigation of samples to understand the composition of the defects.

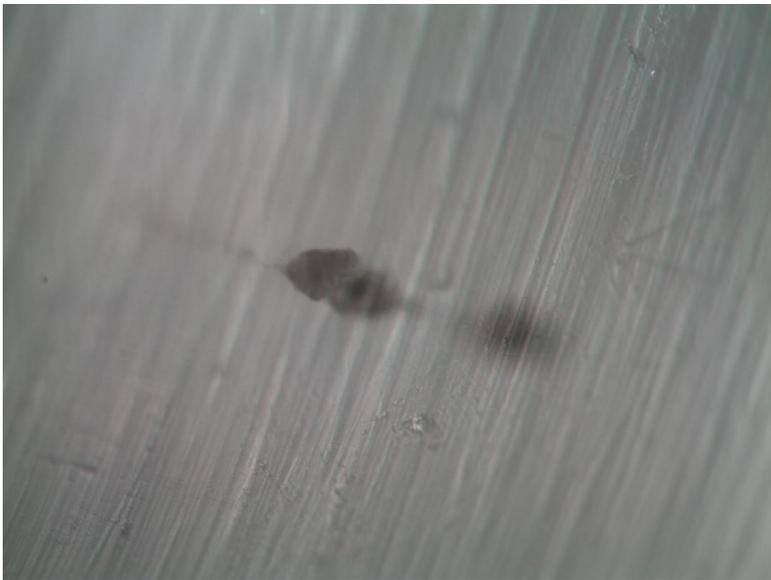
*Figure 1 Black agglomerate.*

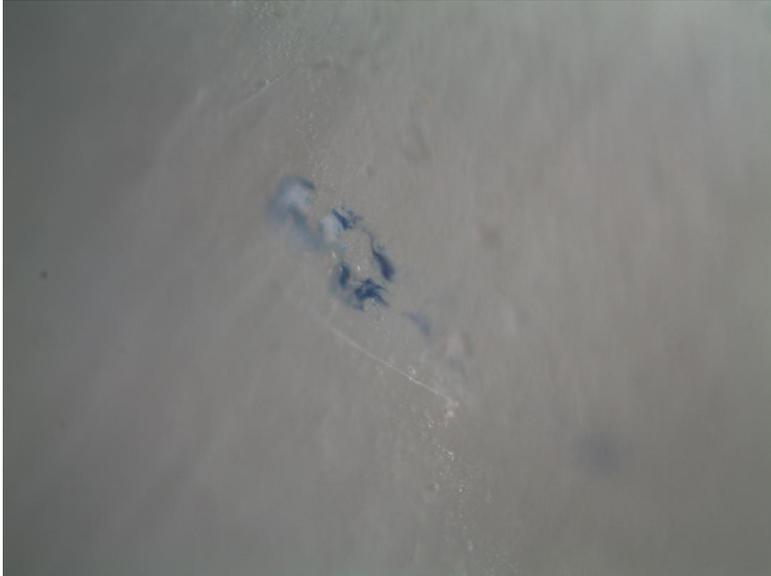
*Figure 2 Blue agglomerate.*

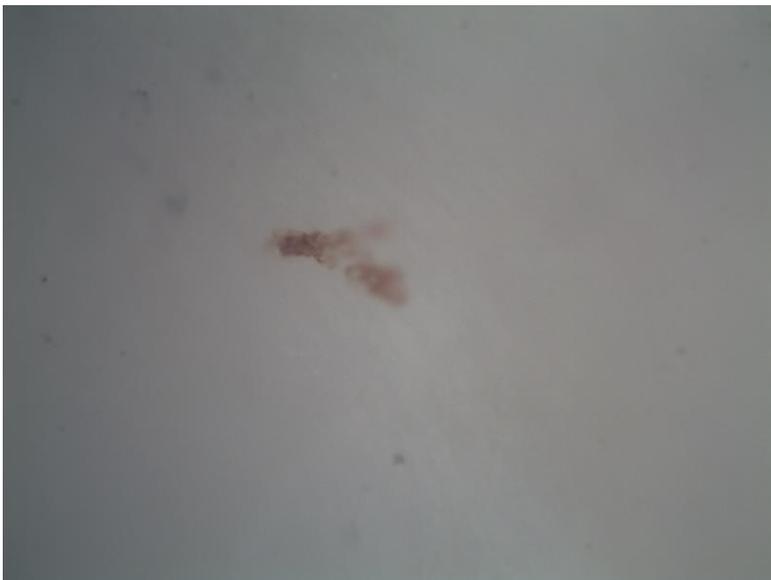
*Figure 3 Red spot.*

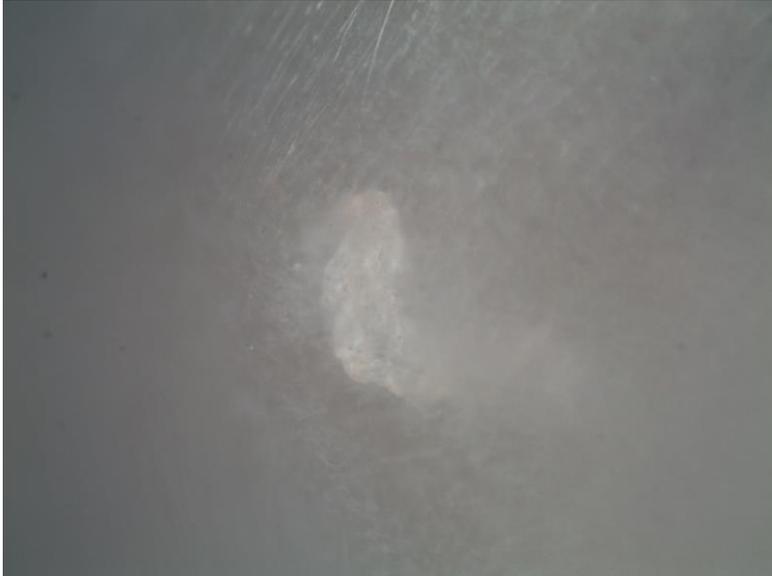
*Figure 4 white spot.*

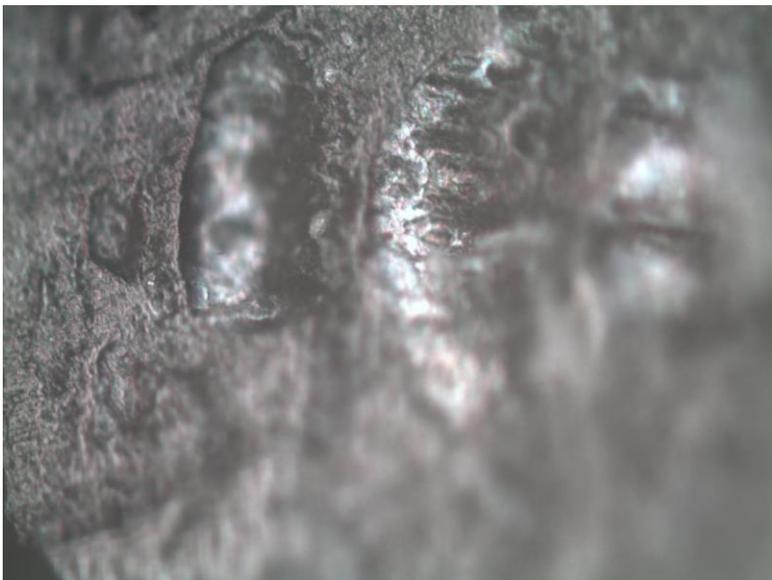
*Figure 5 white block (10X).*

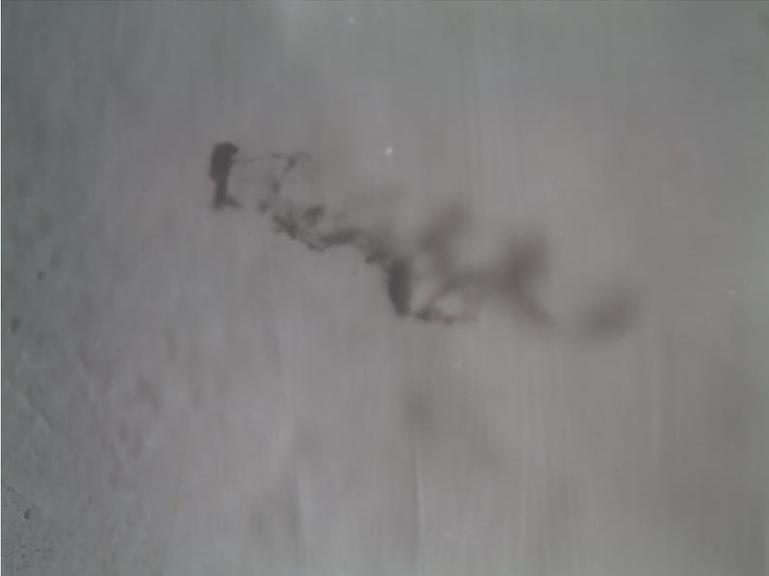
*Figure 6 undefined defect.*

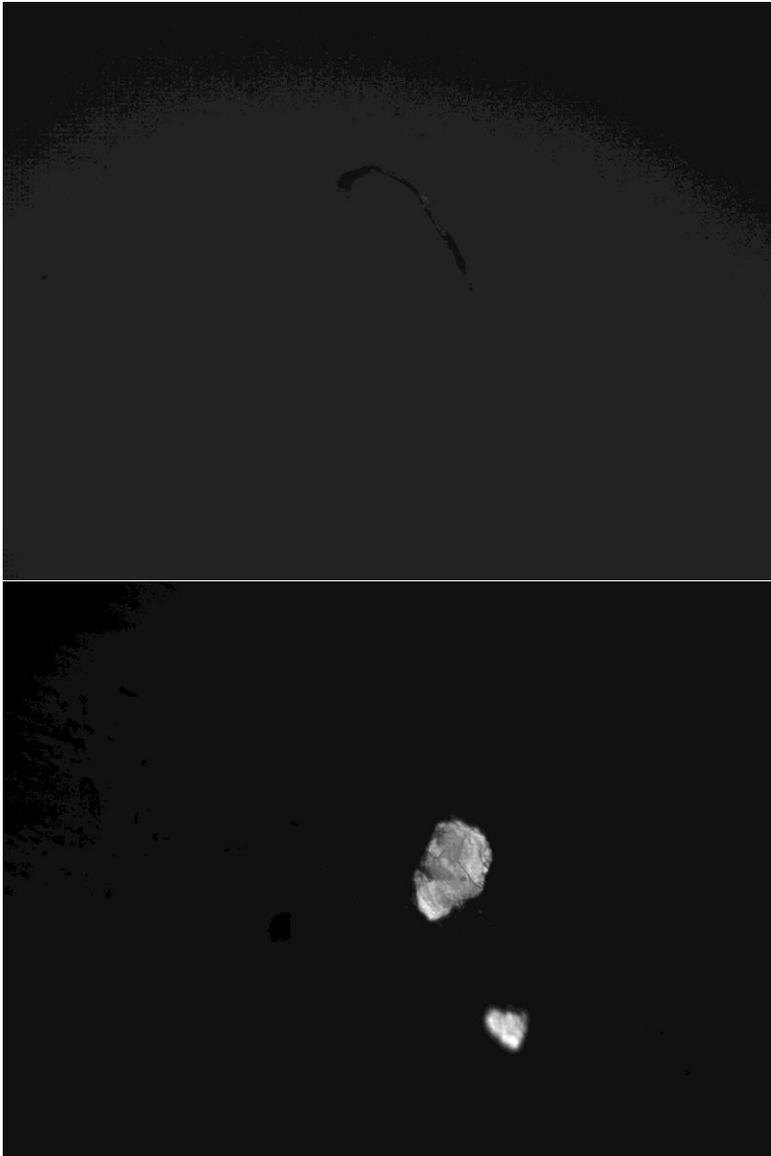
*Figure 7-8 Fiber defect: the fiber is clearly inside the PMMA matrix. In the fig. 8, the presence of other cluster inside the polymeric matrix.*

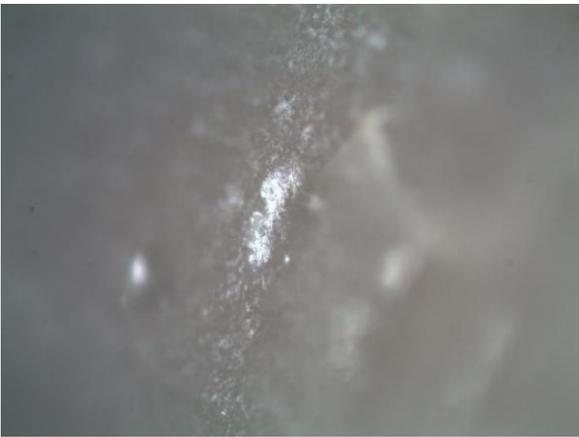
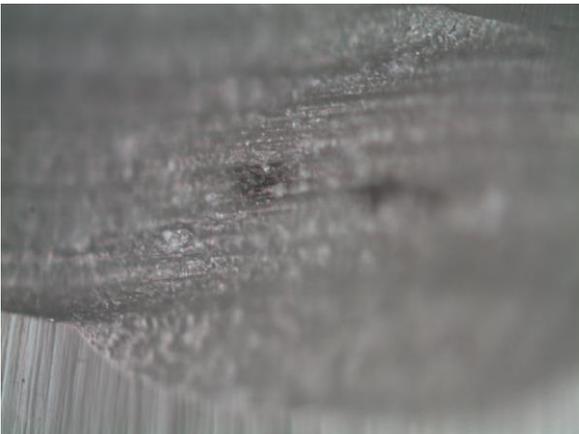
Figure 14-15 optical images of the defect after the removal of pmma resin by blade or abrasive paper.

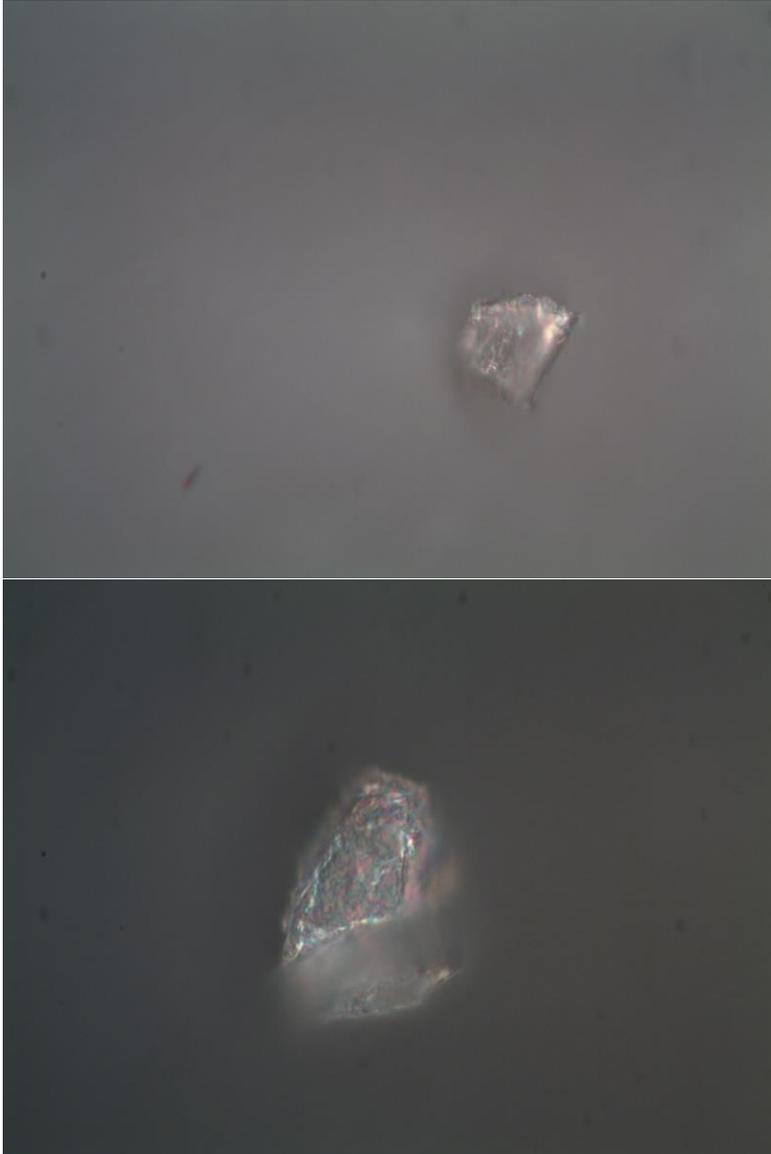
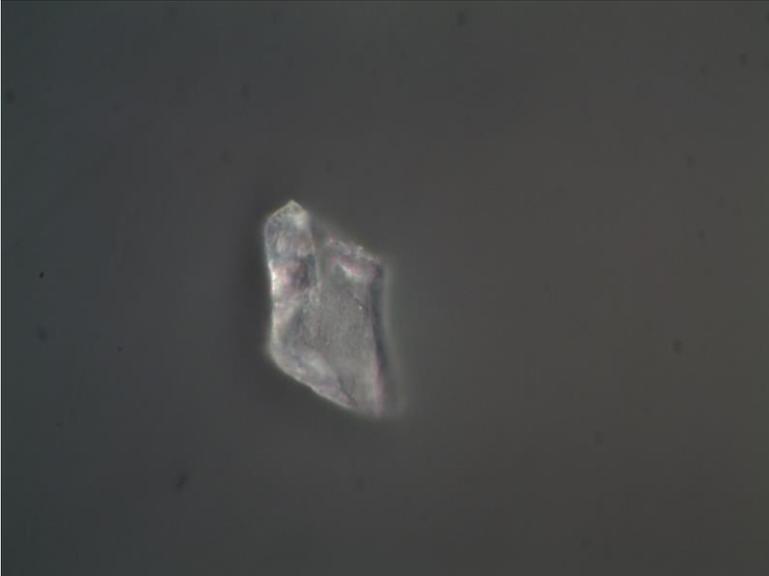
An interesting observation from the polished sample is the presence of other defect, such as crystals, inside the tooth bulk, as visible from the optical microscope image (fig.9). We suppose the defects visible on the teeth (at least the white ones) are the ones close to the surface, but they are largely present also inside the matrix of the sample.

Figure 16-17-18 optical images of the defects after the removal of pmma resin by polishing. All the defects were present in the same sample. Mag: 50X

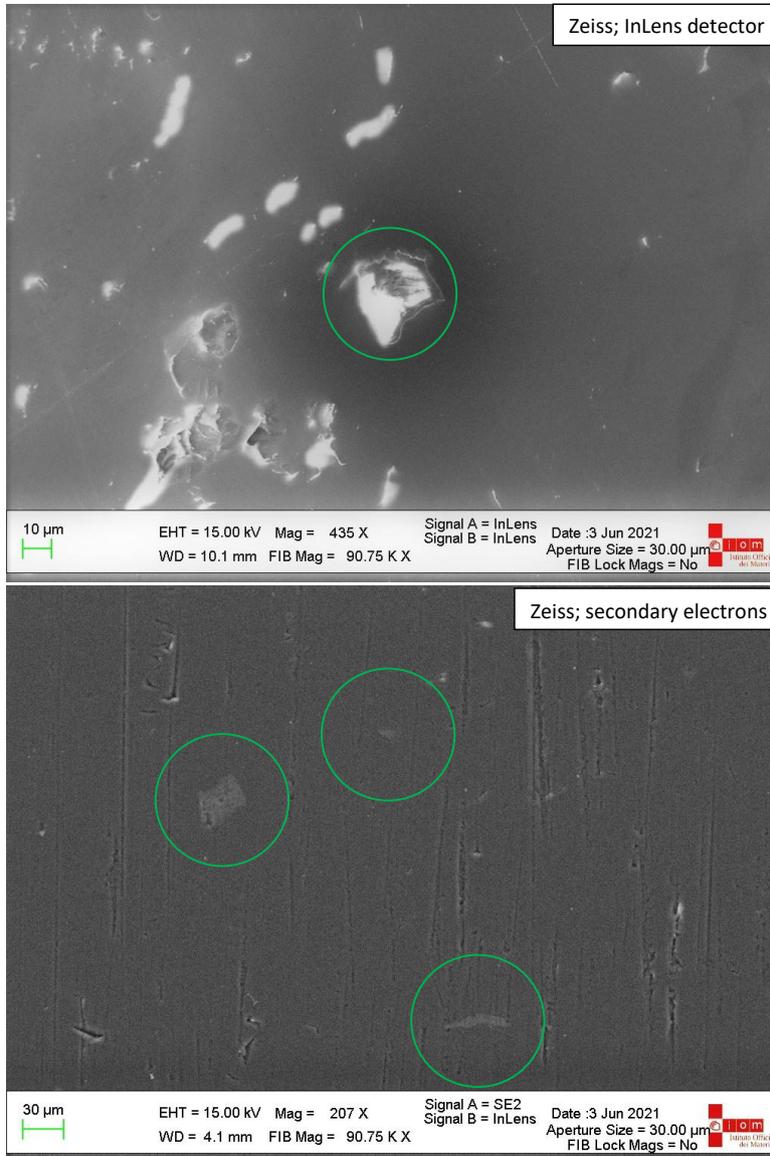
Figure 19-20 SEM image of two defects («unclassified defect» sample). Defects are indicated by green circles.

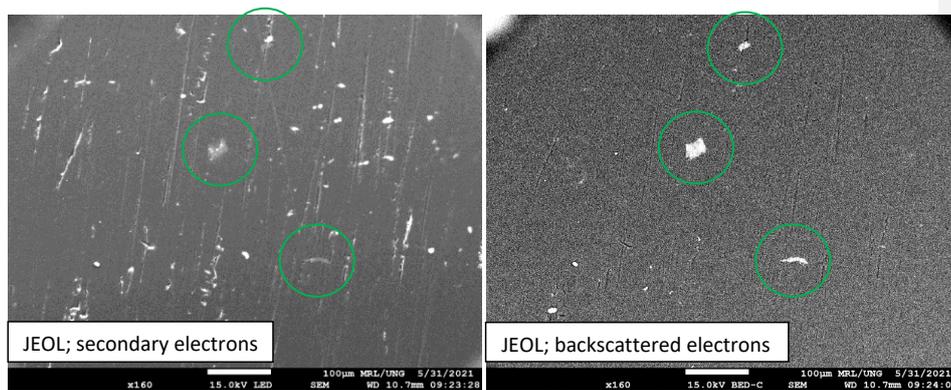
Figure 21 SEM image of the same defect imaged in fig.9, with secondary electrons (left) and backscattered electrons (right).

The defects are visible with the secondary electrons, but the contrast is higher with the backscattered electrons, which confirm the different composition of the defects with respect to the PMMA matrix.

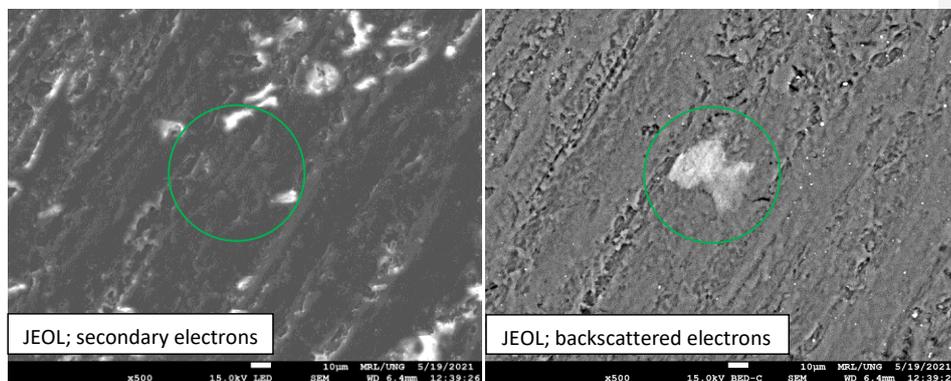
With the backscattered electron detector, the defects are localized even when they are not really at the surface, but slightly below it. In the next images (both acquired on the same area), the defect is not visible with secondary detector (left image), but it is clearly localized with backscattered (right).

Figure 22 SEM image of the same area acquired with secondary electrons (left) and backscattered electrons (right).

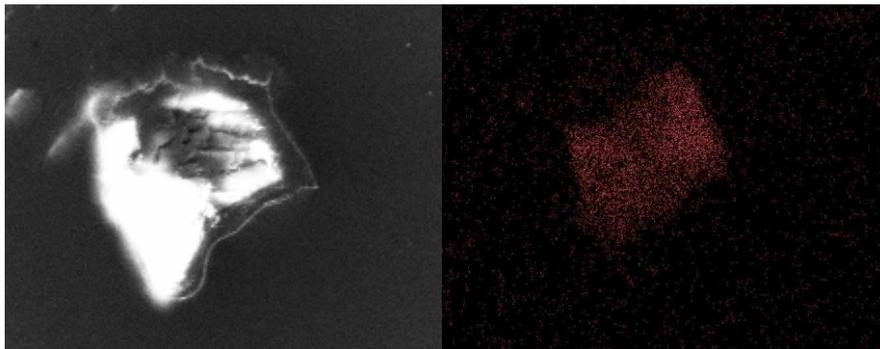
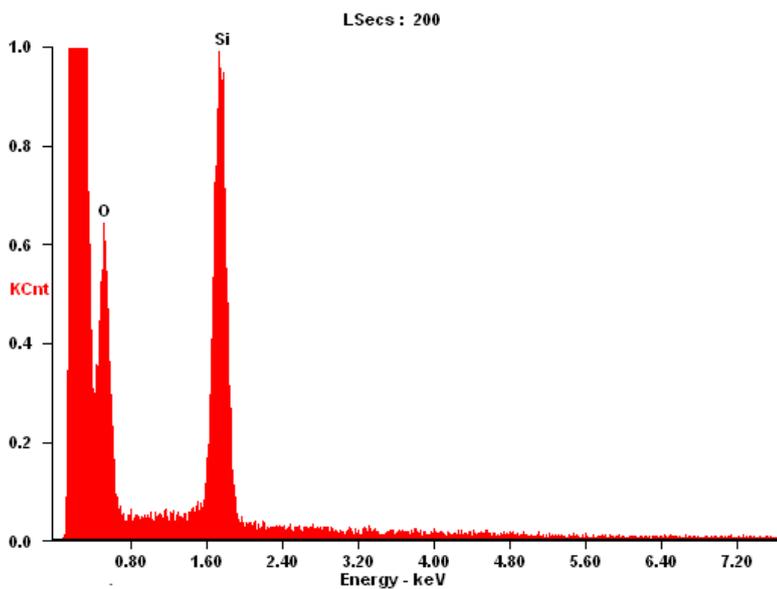
From the EDS analysis, we just measured the signal of Si and O, no other elements can be found. We suppose, if present, the amount of contaminant is below the detection limit.

Figure 23-24 SEM image of a defect, correspondent EDS maps of Si and EDS spectrum of a defect after polishing. Beside the C from the PMMA matrix, the only detected elements are Si and O.
