THE EXPERIMENTAL CAMPAIGN AND NUMERICAL SIMULATIONS OF THE CONSTRAN PROJECT

TECHNICAL REPORT – PART 1

INTERPRETATION OF EXPERIMENTAL RESULTS

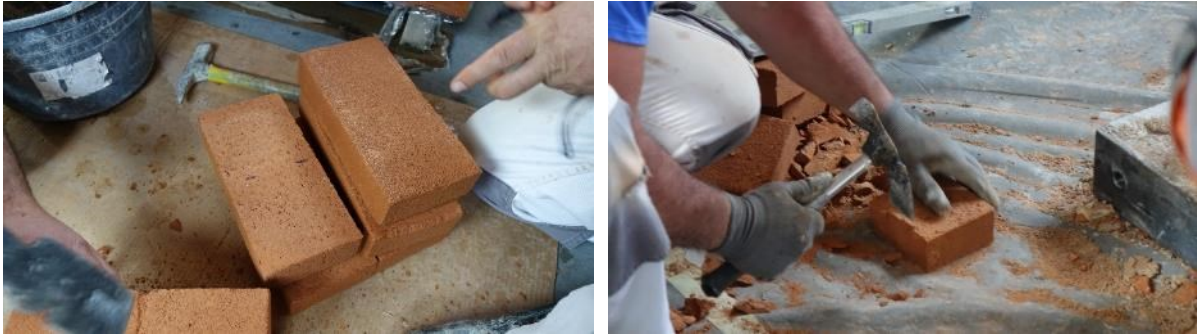
Fig. 2: Sorted bricks (left) and hammering in halves (right).

The commercial name of the solid bricks is *San Marco rosso vivo – Terreal*. A complete description can be found on the producer's website². The photo of the units is shown in Fig. 2, left.

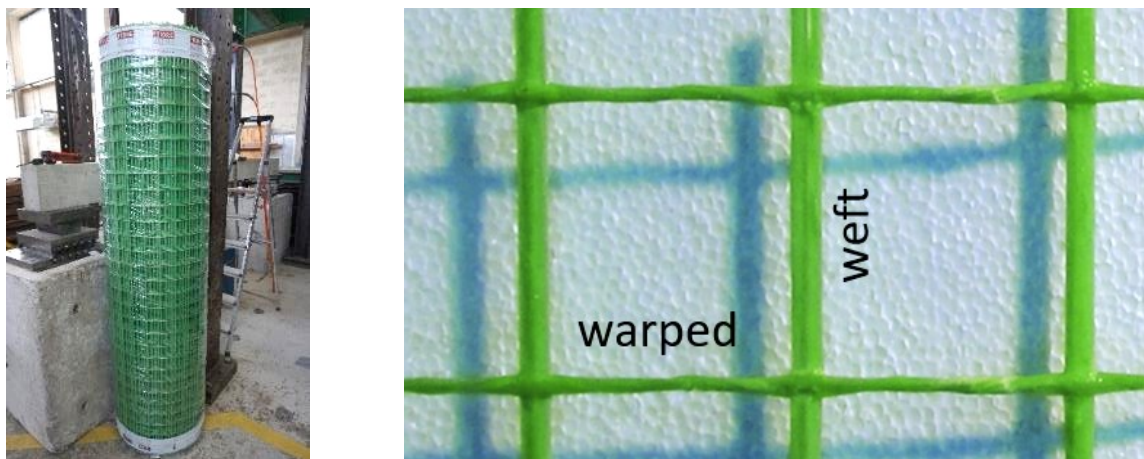
Fig. 5: GFRP mesh for reinforcing was provided in rolls (left). Close-up of the mesh(right).

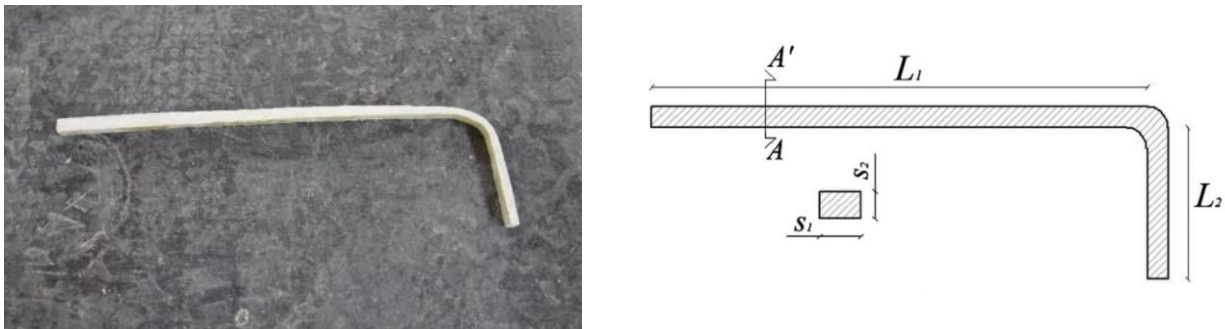
Fig. 7: GFRP "L-shaped" connector.

GFRP connectors were inserted into previously drilled holes and injected with FCVIN 400 CE⁵, a two-component vinylester chemical anchor.

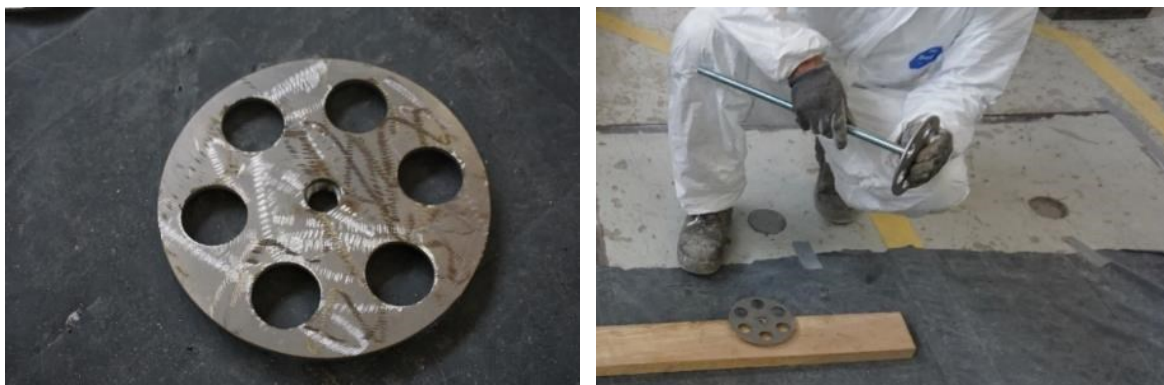
The second type of connector (called "diaton") consists of a threaded stainless-steel M16 bar and a perforated circular steel plate (Fig. 8). The steel plate had a diameter of 150 mm and a thickness of 4 mm. These connectors served two purposes. Firstly, they improve the connection between wall wythes as such connections are often poor in old masonry walls. Secondly, they anchor the mesh to the wall.

Fig. 8: Steel connector or "artificial diaton".

The "diaton" anchors were inserted into 50 mm diameter holes. The hole was then injected with Struttura Tixo – TX 100, a two-component, shrinkage-compensated, fibre-reinforced cementitious mortar with synthetic fibers. Datasheet reports that after 28 days, the mortar reaches a compressive strength of 55 MPa⁶.

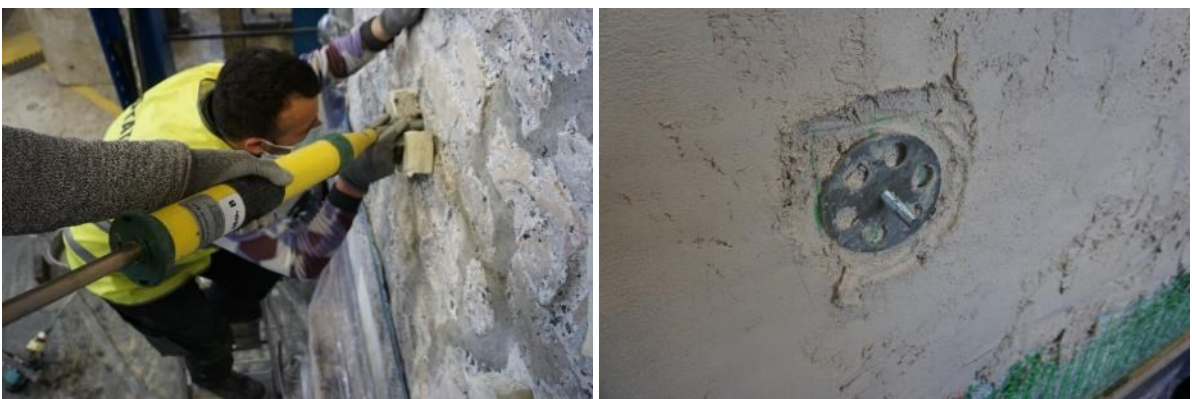
Fig. 18: Injecting TX100 grout (left); installed anchor plate (right).

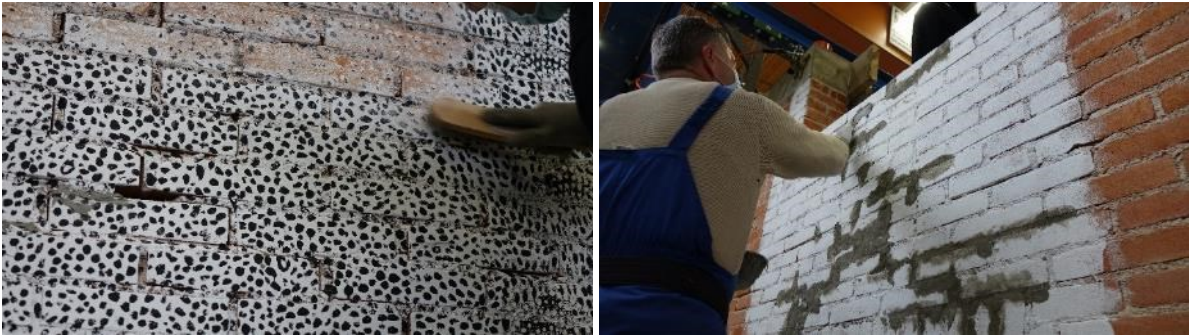
Repair of damaged walls was performed in the same way for stone and brick masonry. In the first step, the surface of the walls was cleaned with a wire brush (Fig. 19, left). Next, the cracks were sealed using the fast-

Fig. 19: Cleaning the surface (left) and sealing the cracks (right).

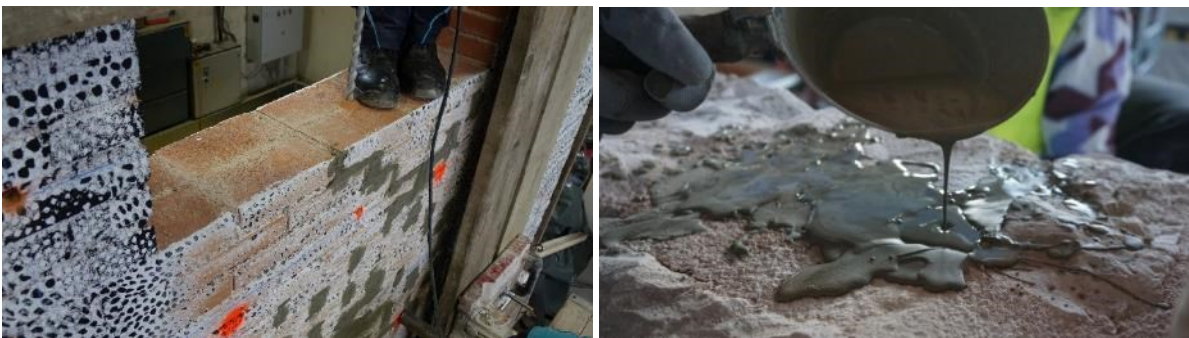
setting mortar (Fig. 19, right). Finally, two holes were drilled into the crack at the top of the wall (Fig. 20, left). The injection was poured through one of them (Fig. 20, right). The injection filled the cracks by gravity.

Fig. 20: Drilling the holes for the injection (left) and gravitational injection of the wall (right).

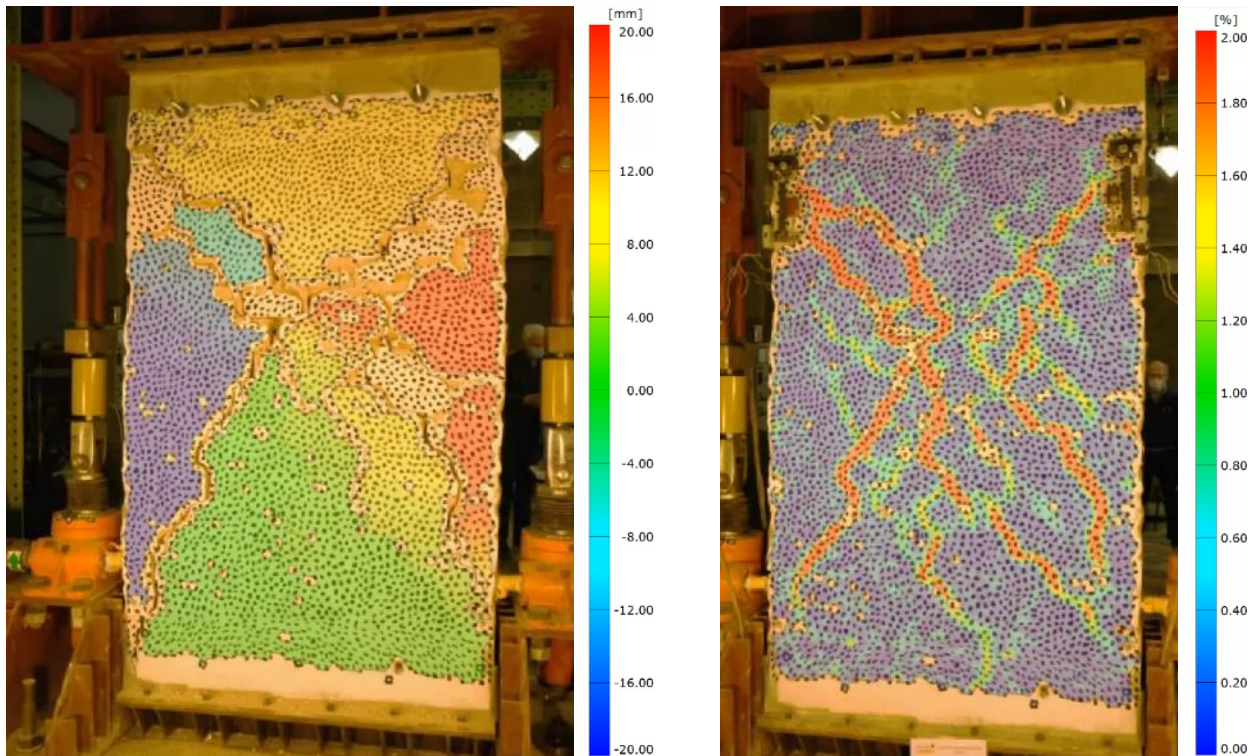
The strain field in Fig. 26, right, shows the strain concentrations. Warm (red) colour indicates cracks, which are mostly diagonal due to shear loads. The system makes it possible to see which cracks open the most.

Fig. 26: Horizontal displacement field by DIC system, left. Strain field by DIC system, right.

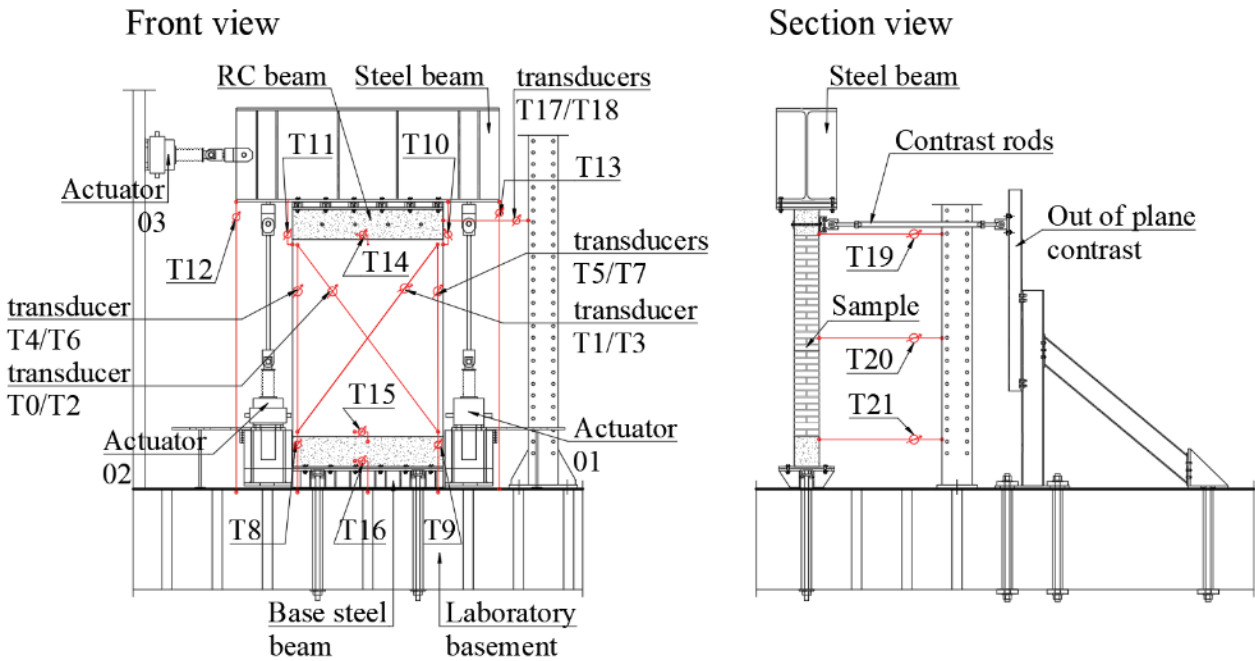
Fig. 28: Test apparatus and instrumentation

The test apparatus in Fig. 28 consists of a strong laboratory floor, to which the foundation block (bottom RC beam) of the wall is fixed using pre-stressed bolts, and a strong steel lattice structure which supports the electro-mechanical actuator (Actuator 03) for imposing horizontal (seismic) loads. A stiff steel beam on the top of the tested pier transfers horizontal and vertical loads to the pier. The vertical load is applied using two electro-mechanical actuators (Actuator 01 and Actuator 02) at the sides of the beam, which are anchored to the laboratory floor. Each electro-mechanical actuator is equipped with a class 1 strain gauge load cell.

Each specimen was equipped with 19 displacement transducers, as shown in Fig. 28. A digital image correlation system (DIC) was used to measure the displacement and strain fields on one surface of the wall. The side facing the cameras of the DIC system was painted with a contrasting random speckle pattern, and the other was painted white to facilitate visual examination of cracks.

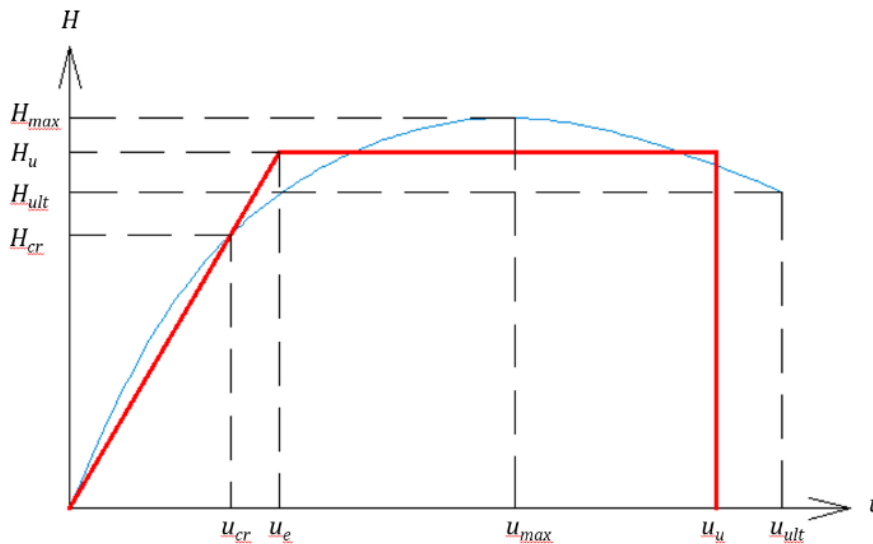
- Stiffness of the bilinear response (K_e) corresponds to secant stiffness at 60 % peak force
- Ultimate displacement (u_u) of the bilinear response is limited to the displacement at the drop to 80 % residual resistance
- The area under the bilinear curve and the envelope (A_{env}) are the same (principle of equality of energy). From this condition, the force (H_u) on the plateau of the bilinear curve is calculated.

Fig. 30: Bilinear idealisation

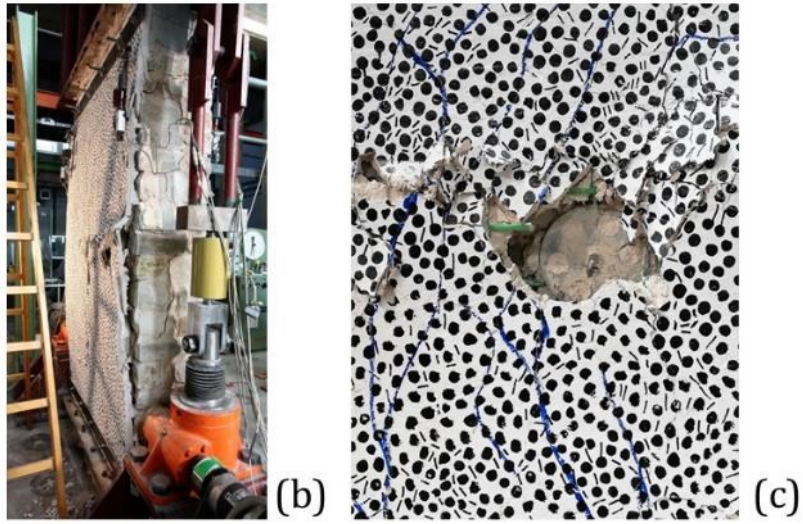
2 mm (0.1 %)	A vertical crack appears in the middle of the wall on the coating and the unstrengthened side.
2 mm – 13 mm	Vertical cracks propagate and multiply on both sides of the wall.
13 -16 mm (0.65 – 0.8 %)	Peak resistance is reached. On the unstrengthened side, a big diagonal crack appears. In the coating, vertical cracks become inclined. Horizontal cracks appear at the base and top of the coating, indicating the presence of flexure. The shear response dominates in the coating.
16 mm – 37 mm	Large diagonal shear cracks on the unstrengthened side. Coating develops many parallel cracks and gradually loses contact with the masonry (Fig. 38, left). Eventually, mortar starts falling off, and GFRP mesh fractures near diatons (Fig. 38, right).

Fig. 38: (P-R2R-1) Detachment of the coating (left), fractured mesh near diatoms (right).

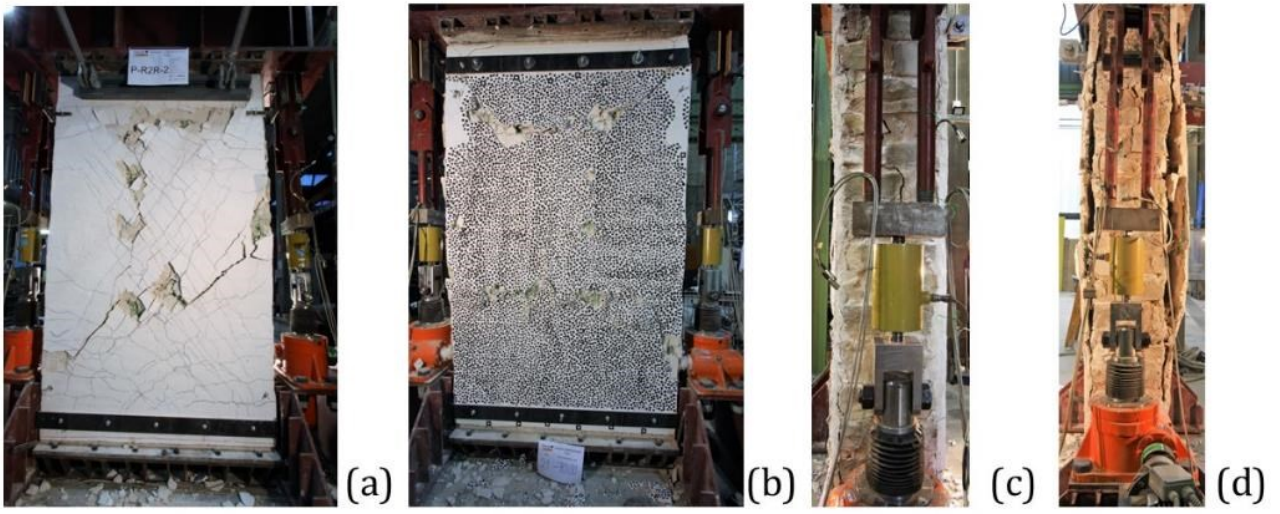
4 mm (0.2 %)	Horizontal cracks in the coating at the base of the wall were the first sign of damage.
4 mm – 5 mm	Inclined cracks appear in the middle of the wall (coating).
20 mm (1 %)	Peak resistance is reached. The damage in the coating consists of horizontal cracks at the base and top of the wall (flexure) and inclined cracks (shear). Several parallel cracks characterise damage due to flexural and shear mechanisms. Bending response dominates.
30 mm	Coating begins to crumble and detach from the wall Fig. 42a,b . There is a vertical crack between the leaves of the wall. Fig. 42c
70 mm	Wall collapses. Cracks at collapse are a mixture of shear and bending Fig. 42d .

Fig. 42: (P-R2R-2) view of the wall at collapse (a and b), vertical cracks between the leaves of the wall (c), detachment of the coating at collapse (d)

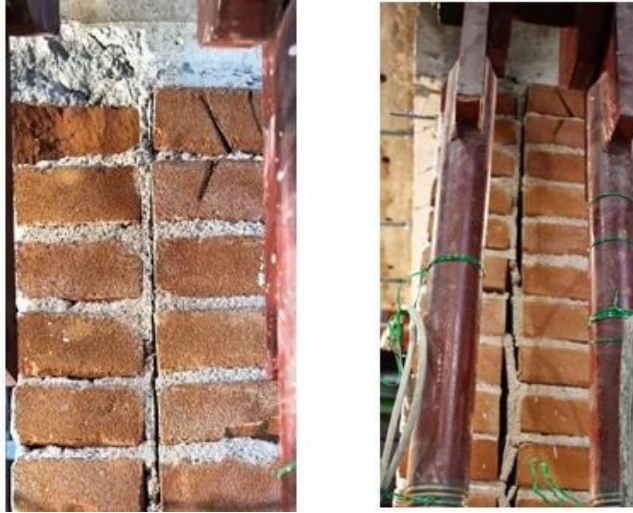
2-3 mm (0.13 %)	The first inclined crack appears in the middle of the wall.
4 mm (0.2 %)	At peak resistance, there is diagonal cracking, which indicates shear response.
8 mm (0.24 %)	Shear diagonal cracks grow in length and width. Cracks indicating separation of leaves are observed (Fig. 52).
15 mm (0.75 %)	Failure due to diagonal shear cracking occurs. Damage is concentrated in two principal cracks. Severe separation of wall leaves (Fig. 52).

Fig. 52: (P-B2U) Separation of wall leaves at 8 mm (left) and 15 mm (right)

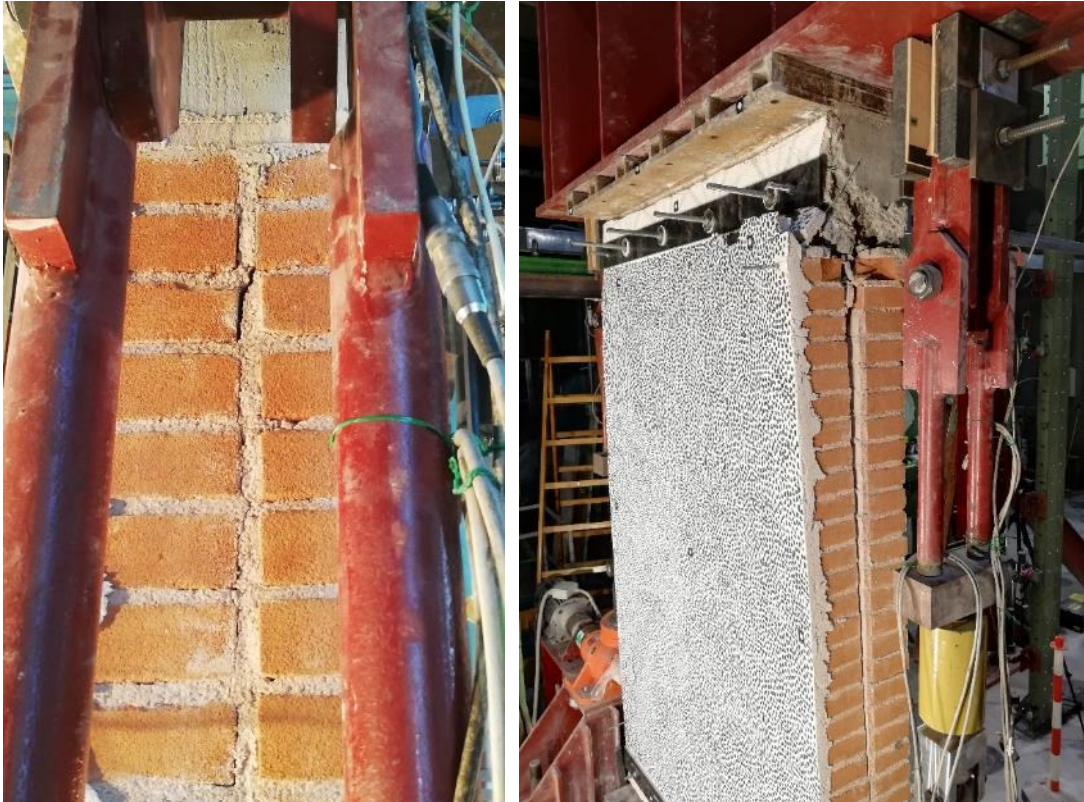
3 mm (0.15 %)	Horizontal cracks in the coating at the top of the wall were the first sign of damage.
4 mm – 20 mm	Horizontal cracks also appear at the bottom of the wall, and cracks at both locations propagate. At about 10 mm, crack formation between wall leaves occurred (Fig. 56, left).
20 mm (1 %)	Peak resistance is reached. The damage in the coating concerns horizontal cracks at the base and top of the wall (flexure). Bending response dominates in the coating. However, a large diagonal crack appears on the unstrengthened side.
20 – 40 mm	In the coating, the flexural response continues to dominate. However, shear cracks also appear in the coating. On the unstrengthened side, shear damage progresses.
70 mm	Wall collapses. Cracks at collapse are a mixture of shear and bending. Wall leaves are entirely detached, and the leaf with the coating is leaning heavily out of the plane (Fig. 56, right)

Fig. 56: (P-B2R-1) Vertical crack between wall leaves at 10 mm (left) and separation of leaves at 70 mm (right).

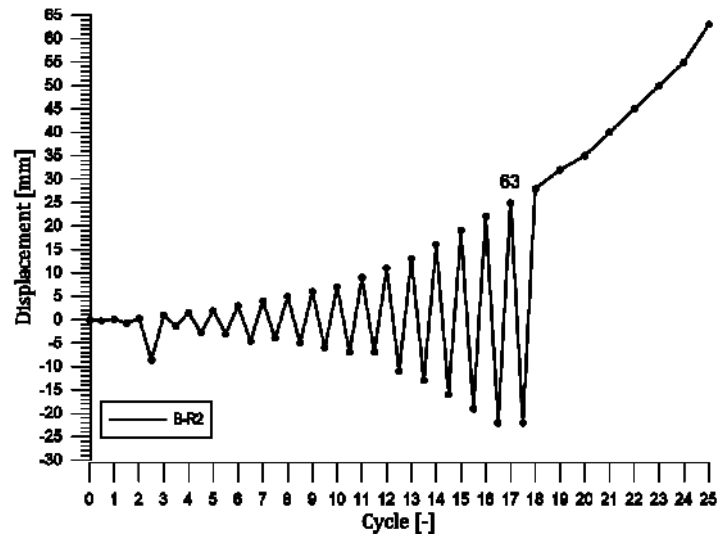
Fig. 73: Horizontal displacement sequence for specimen B-R2

A typical load protocol is shown in Fig. 73.

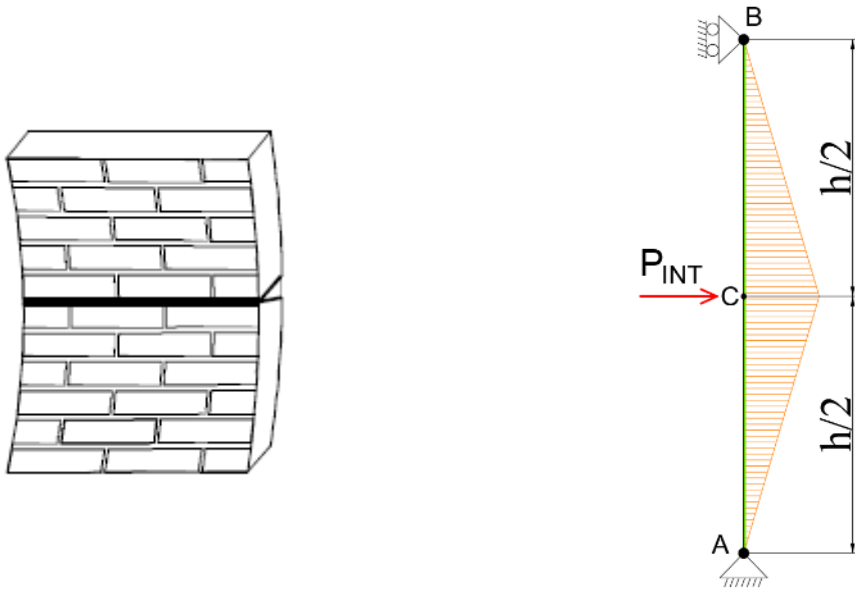
Fig. 74: Failure with exhausted f_{x1} (left), bending moment in the element (right)

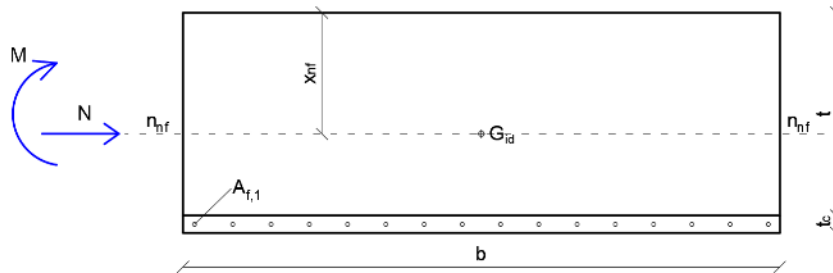
The cross-section equilibrium is calculated on an idealised cross-section shown in Fig. 75.

Fig. 75: Scheme of the cross-section.

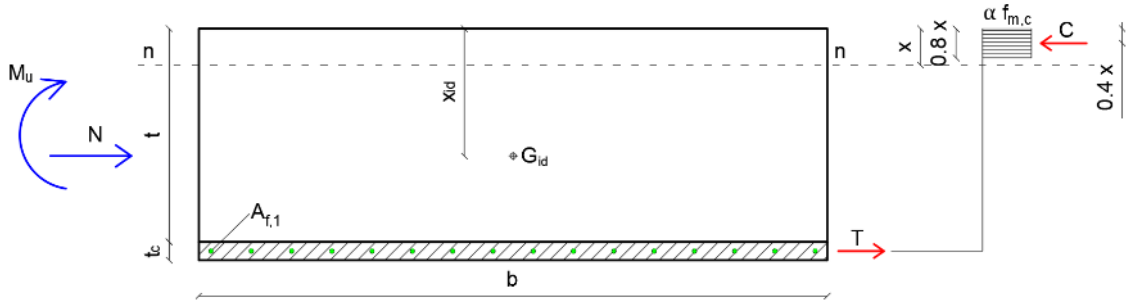
The calculations are for the case when the coating is in tension, and the unstrengthened side is in compression. It makes it possible to estimate resistance to out-of-plane loads.

Fig. 76: Stress distribution at ultimate resistance

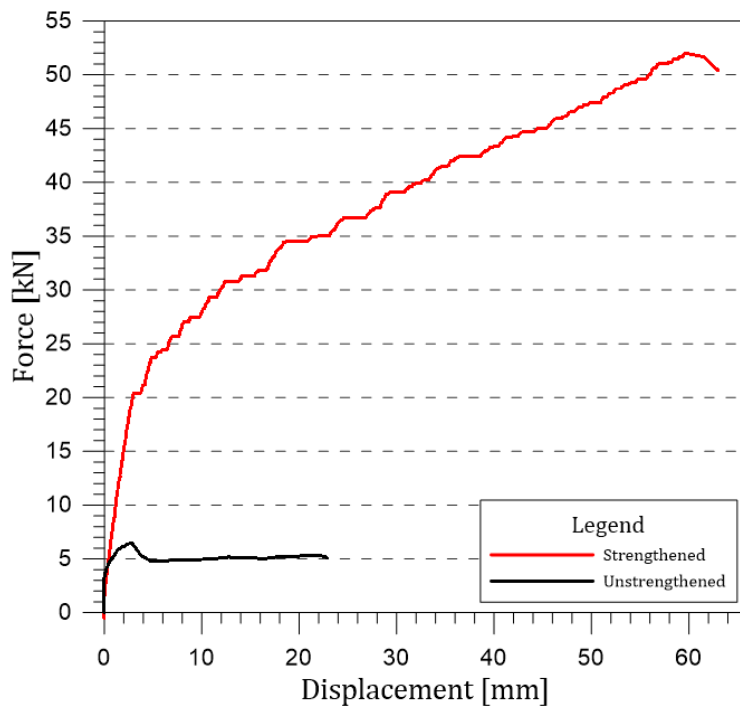
Fig. 79: Envelope curves for specimen B-R2

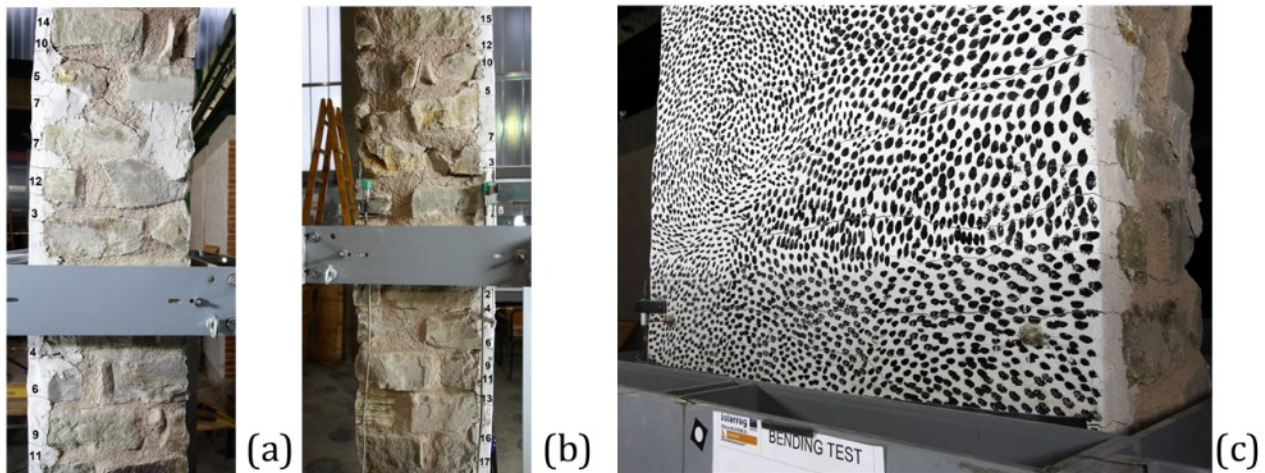
Starting at $u = 22$ mm, two diagonal cracks formed in the thickness of the wall due to punching shear. They originated from the loading plate and propagated in as shown in Fig. 81a and b.

Fig. 81: Cracks due to punching shear at $u = 35.0$ mm, right view (a), left view (b) and front view (c)

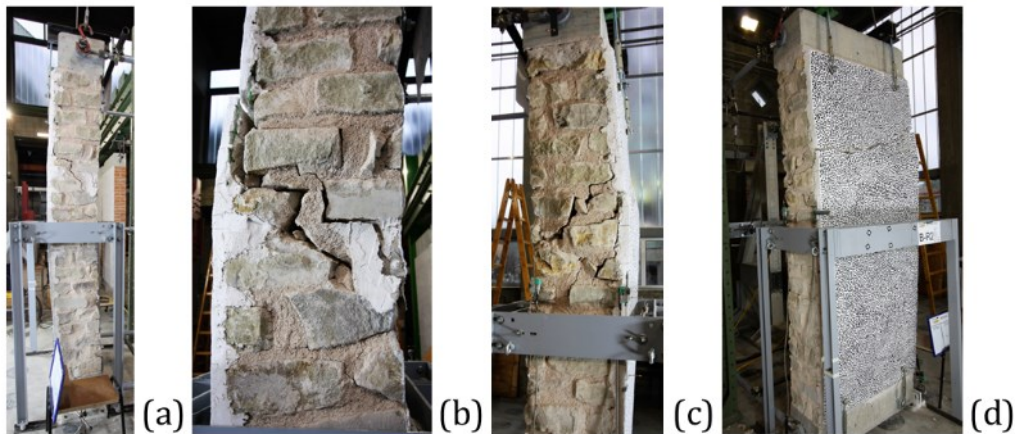
At the end of the test ($u = 63.1$ mm), the coating had multiple, mostly horizontal cracks on the reinforced coating, and the main crack located at about $\frac{3}{4}$ of the masonry height. In Fig. 83 b, c and d, the final collapse of the specimen is shown.

Fig. 83: Crack pattern at $u = 55.0$ mm (a) and at the end of the test, right view (b), left view (c), front view (d)

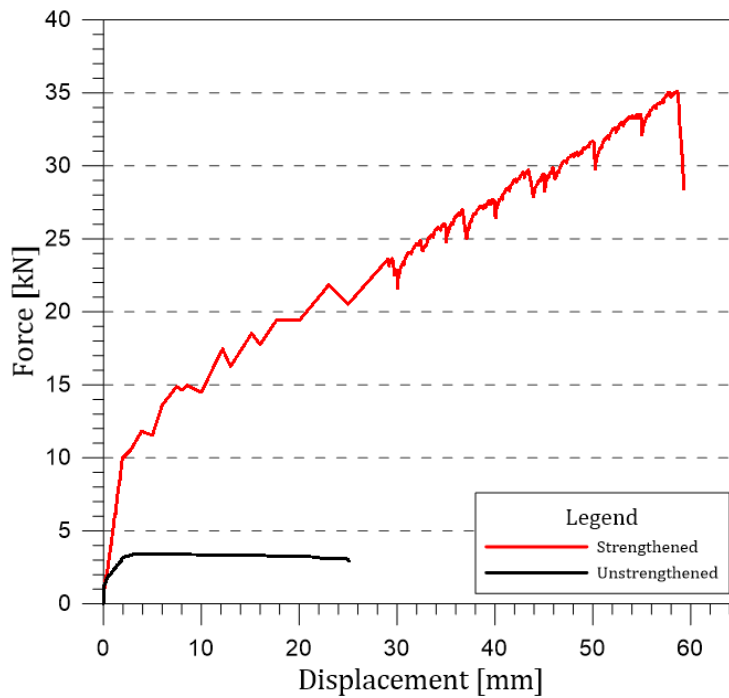
Fig. 86: Envelope curves for specimen B-B1

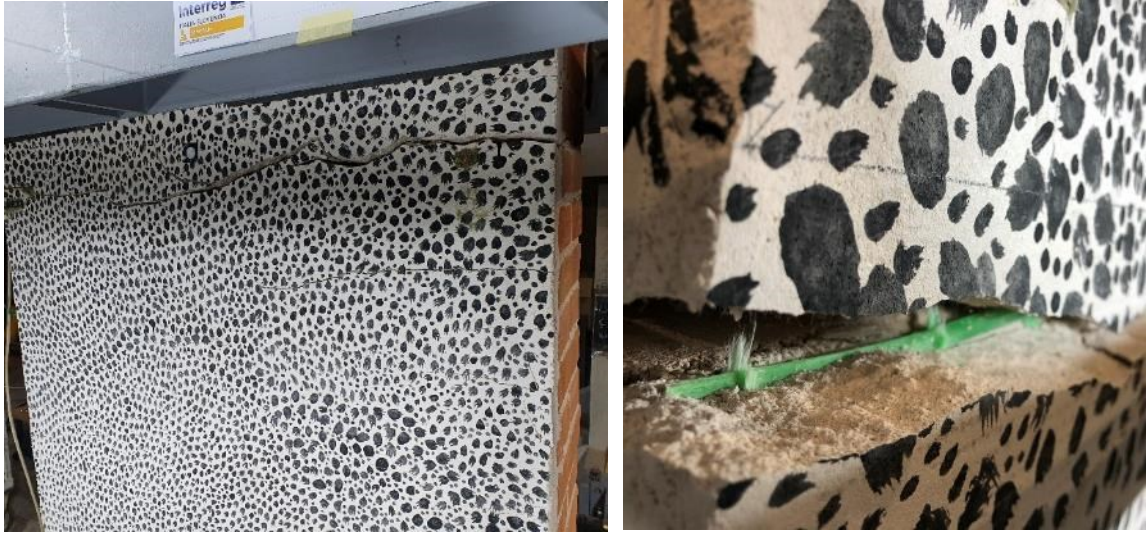
At collapse, the GFRP mesh in the coating fractured (Fig. 89). The collapse occurred at a displacement of 58.6 mm and a force of 36 kN.

Fig. 89: Fracture of GFRP mesh at collapse.

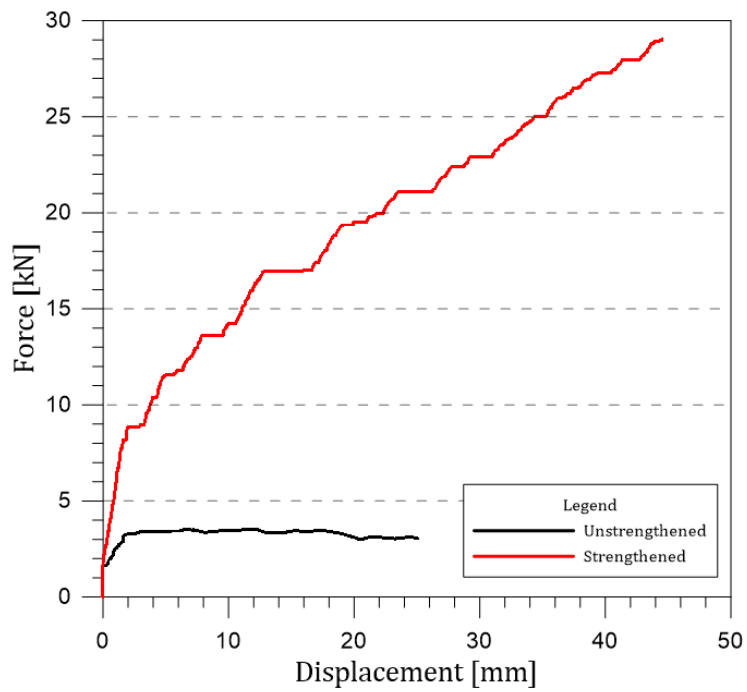
Fig. 91: Envelope curves for specimen B-B2

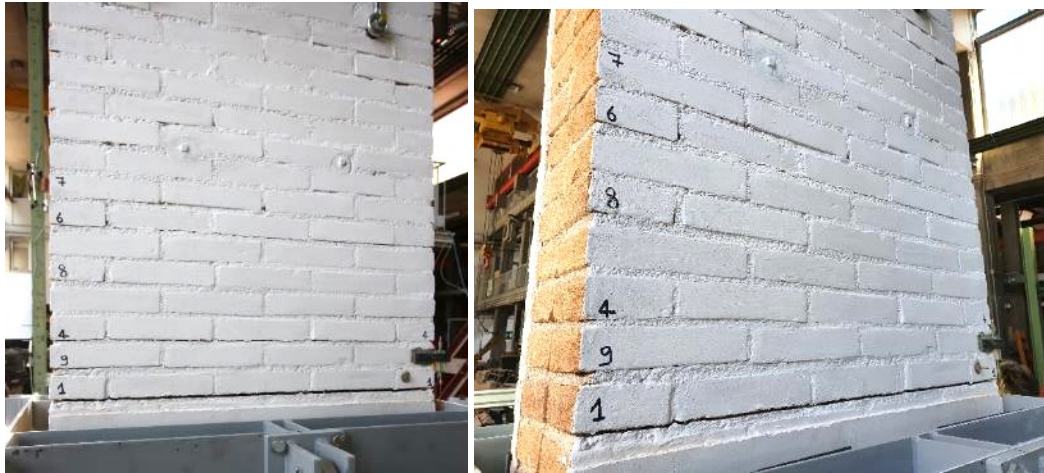
The first crack occurred on the unreinforced side, in the middle section (Fig. 92), at $u = -2.0$ mm and a force of 3.3 kN. The crack pattern (mechanism) on the unstrengthened side stabilized after $u = -5$ mm was reached. The test was conducted cyclically until $u = -25$ mm. After this, the test was conducted monotonically by pushing towards the strengthened side (coating in tension).

Fig. 92: Cracks on the unstrengthened side.

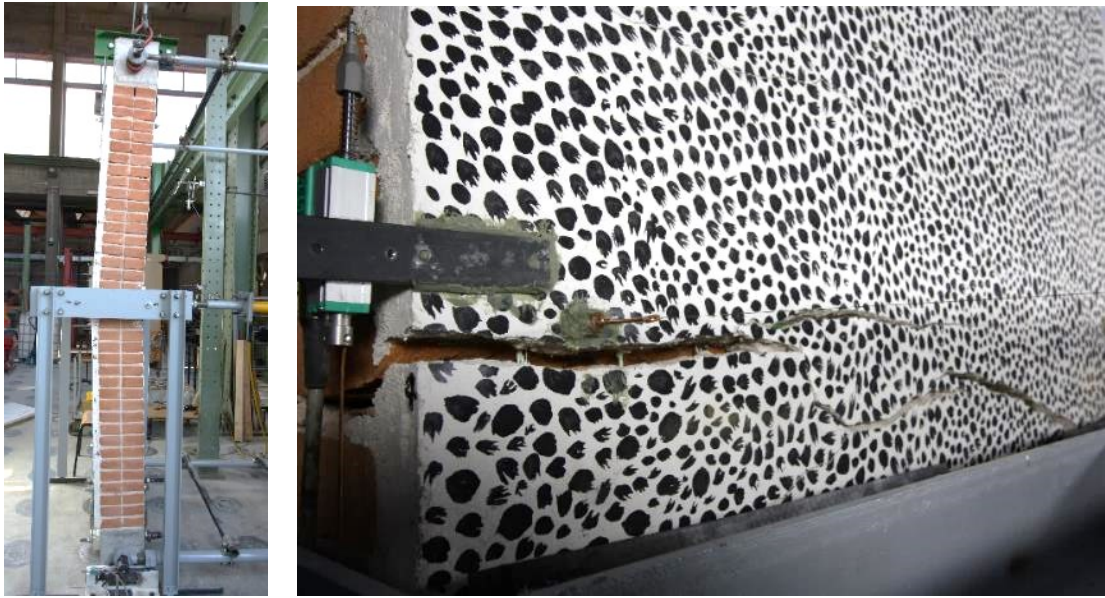
At collapse, the GFRP mesh in the coating fractured (Fig. 89). The collapse occurred at a displacement of 44.5 mm and a force of 29 kN.

Fig. 94: Fracture of GFRP mesh at collapse.

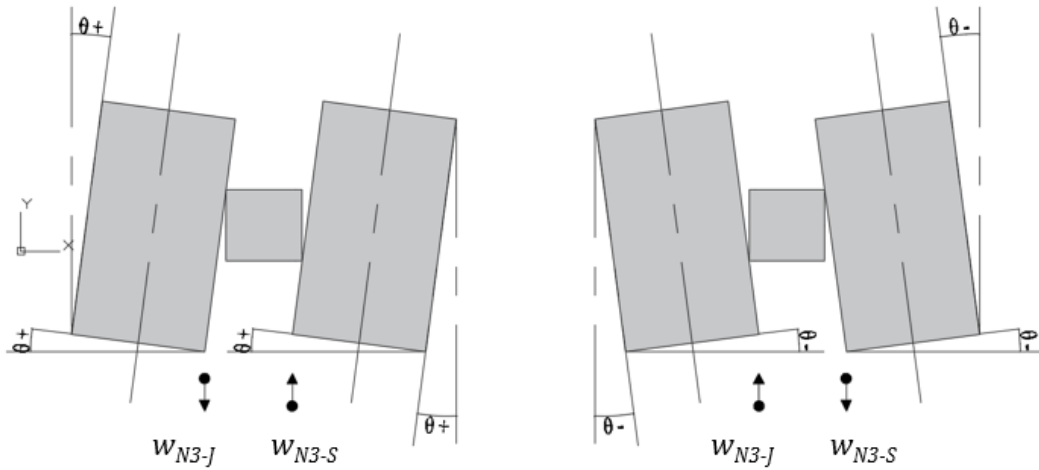
Fig. 98: Positive (left) and negative (right) directions of loading

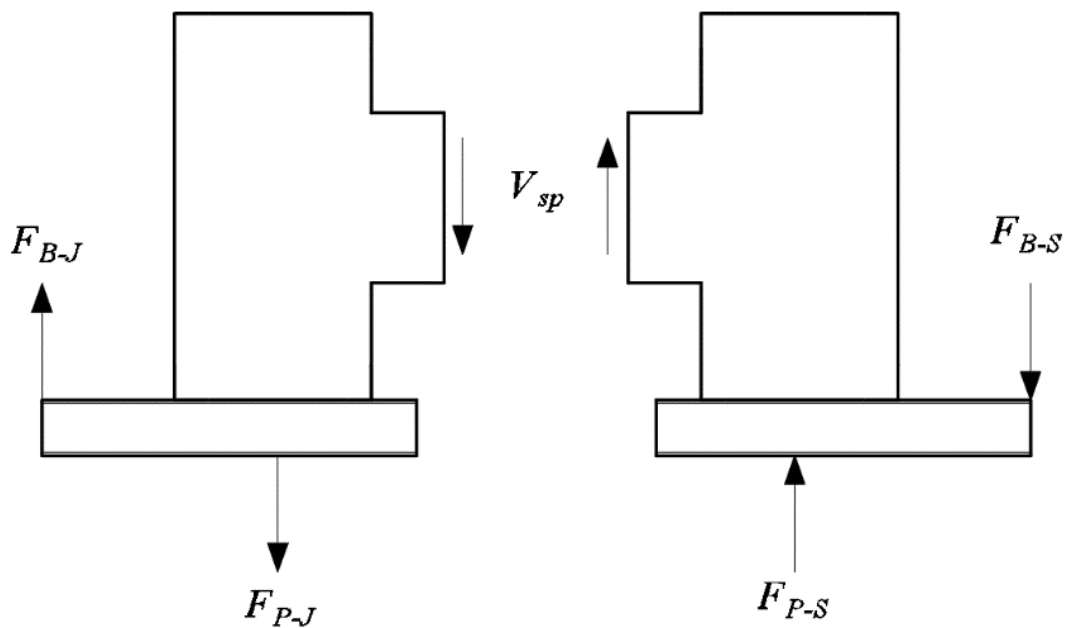
Shear force in the spandrel (V_{sp}) was computed indirectly by considering the forces measured in the actuators (F_B) and the supports (F_P), which were set to zero at the beginning of the test, as shown in Fig. 99, thus self weight was not considered during the test. It should be noted that the load also causes bending moments in the spandrels.

Fig. 99: Shear force in the spandrel

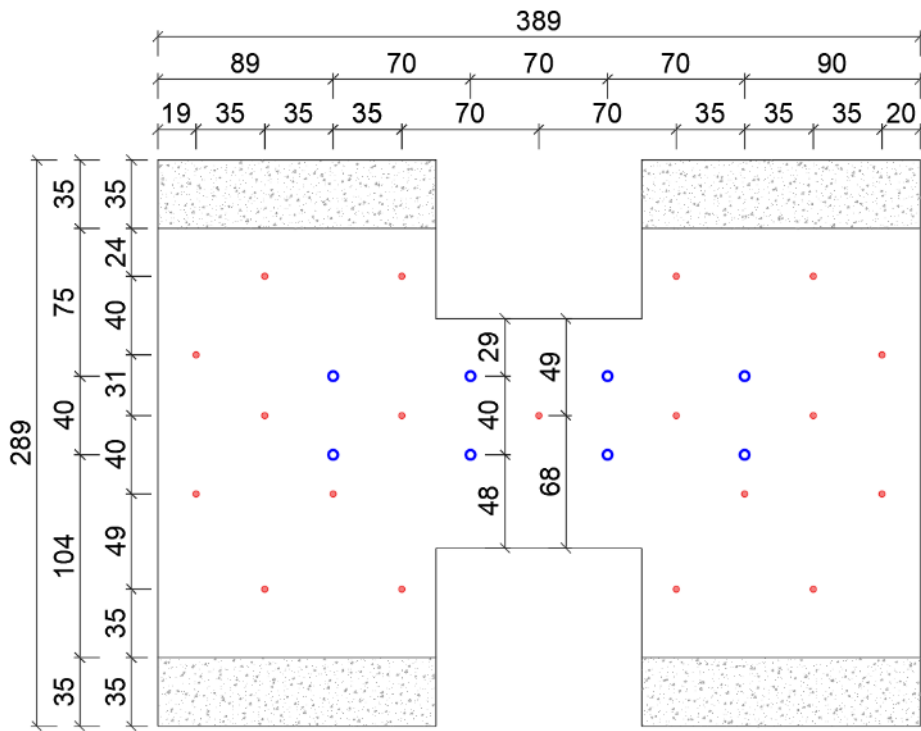
Fig. 104: Schematic of strengthening for S-R2R-1. Red circles = L connectors, Blue circles = diatons.

S-R2R-1	Two leaf stone masonry; <i>Strengthened on one side</i> 19 »L« connectors, 8 diatons		
Date of test:	2021/6/1	Bilinear idealization	
Age of sample/coating:	96/40 days	Φ_e	0.13 %
Spandrel length l_{sp} :	1065 mm	Φ_u	2.21 %
Vertical stress in piers (σ_0):	0.33 Mpa	H_u	65.8 kN

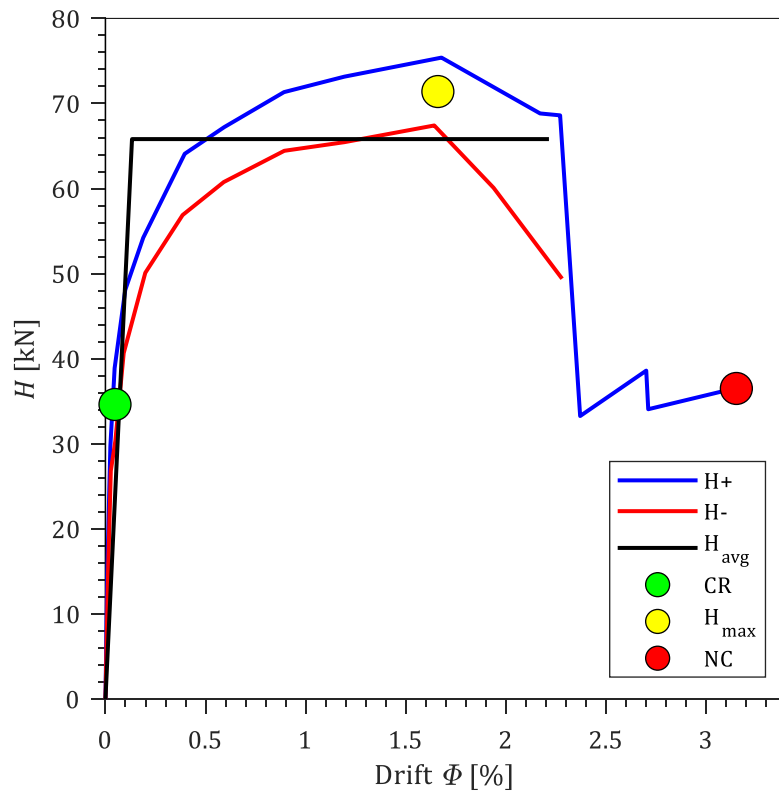
Fig. 106: Envelopes of the response, bilinear idealization and limit states.

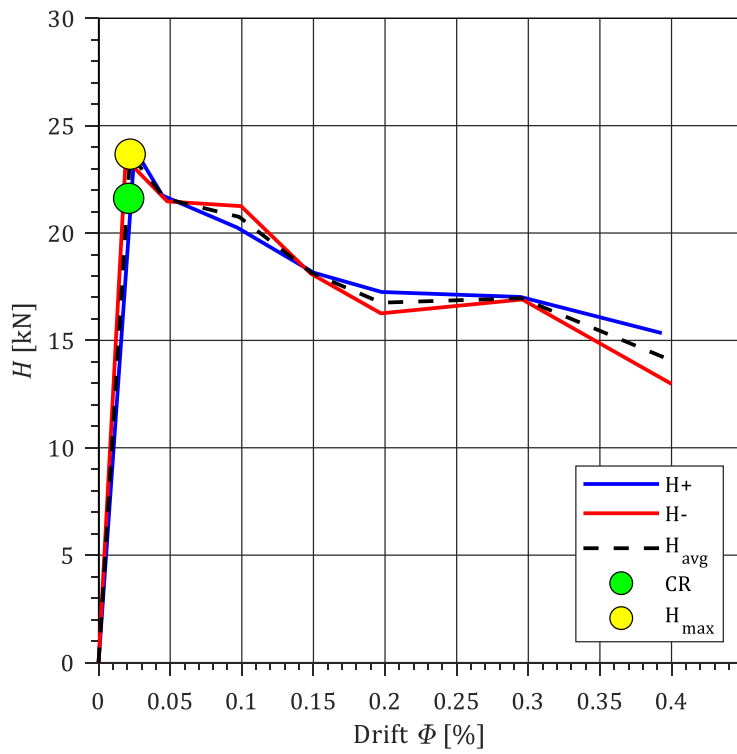
Fig. 110: Envelopes of the response and limit states.

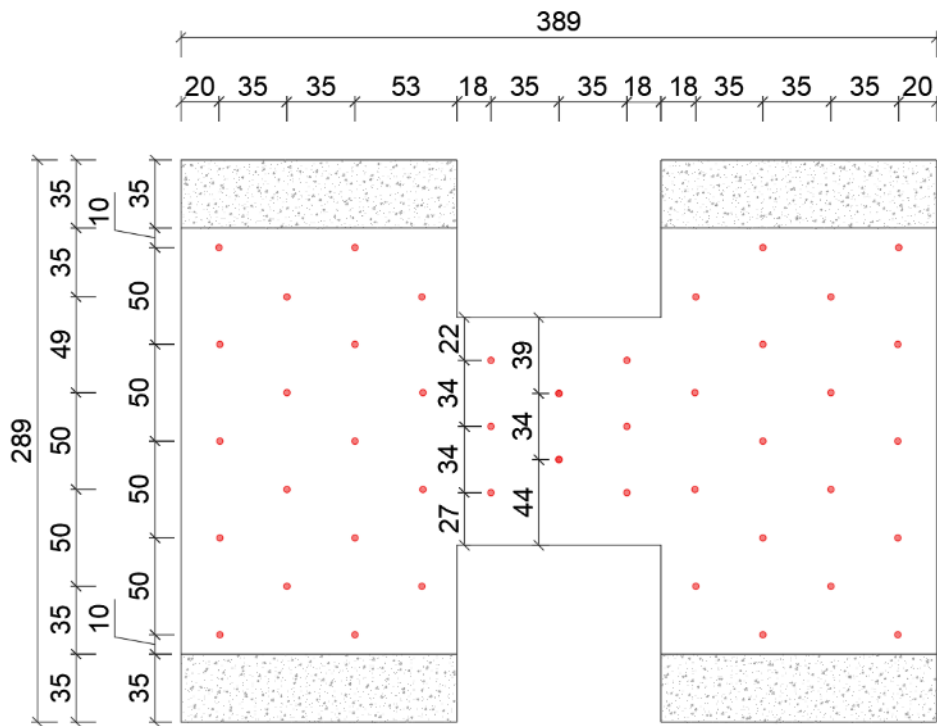
Fig. 111: Schematic of strengthening for S-R2R-2

S-R2R-2	Two leaf stone masonry; <i>Strengthened on one side</i> 44x2 »L« connectors		
Date of test:	2021/25/8	Bilinear idealization	
Age of sample/coating:	69/37 days	Φ_e	0.12 %
Spandrel length l_{sp} :	1065 mm	Φ_u	2.73 %
Vertical stress in piers (σ_0):	0.33 MPa	H_u	80.0 kN

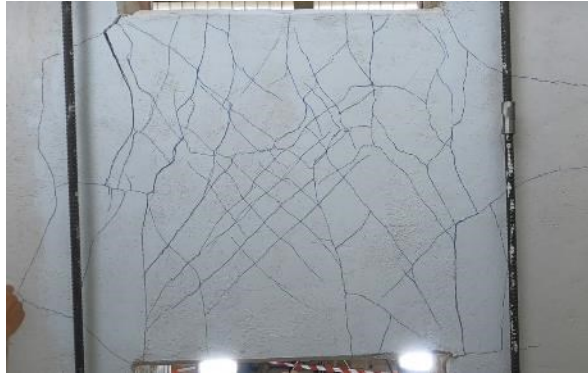
Fig. 114: Crack pattern at maximum resistance

Drift	Observation
0.025 %	The first cracks were vertical at the top left and bottom right corner of the spandrel. The force at this stage was about 56.4 kN.
0.1 %	Vertical cracks extended and reached across the whole height of the spandrel.
0.1 – 1.69 %	Inclined cracks appeared in the coating. The number of cracks gradually increased and covered the whole surface of the coating.
1.69 %	Peak resistance was reached. The response at peak resistance was clearly flexural (Fig. 114) despite many inclined cracks.
1.68 – 3.0 %	The cracks opened and closed and got gradually wider. New inclined cracks appeared in the coating. Ultimately the vertical section at the edge of the spandrel failed (Fig. 115). Towards the end of the test, wall leaves separated in the piers below the lintel (Fig. 116).

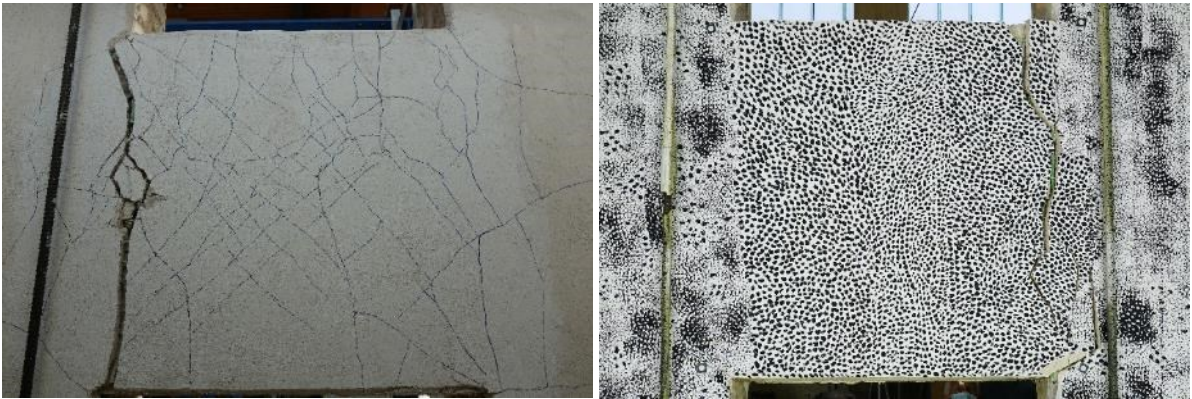
Fig. 115: Final failure

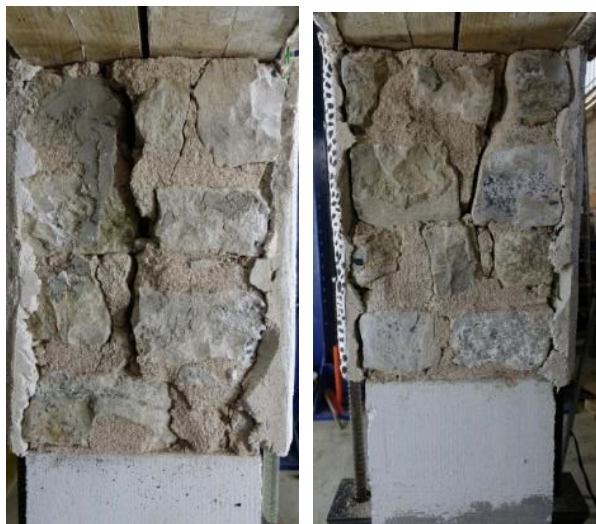
Fig. 116: Separation of wall leaves in piers

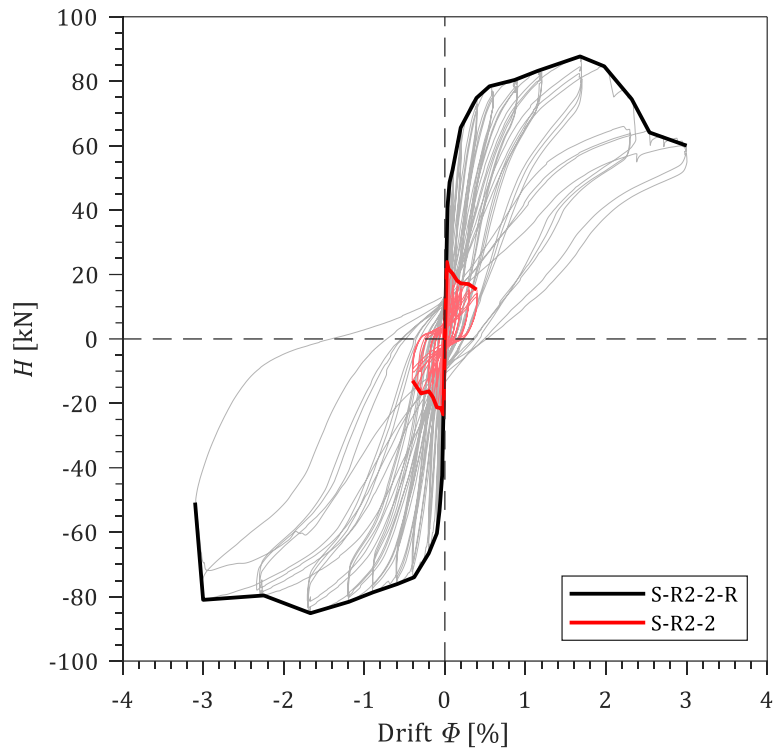
Fig. 131: Hysteretic curves and envelopes of unstrengthened and strengthened wall.

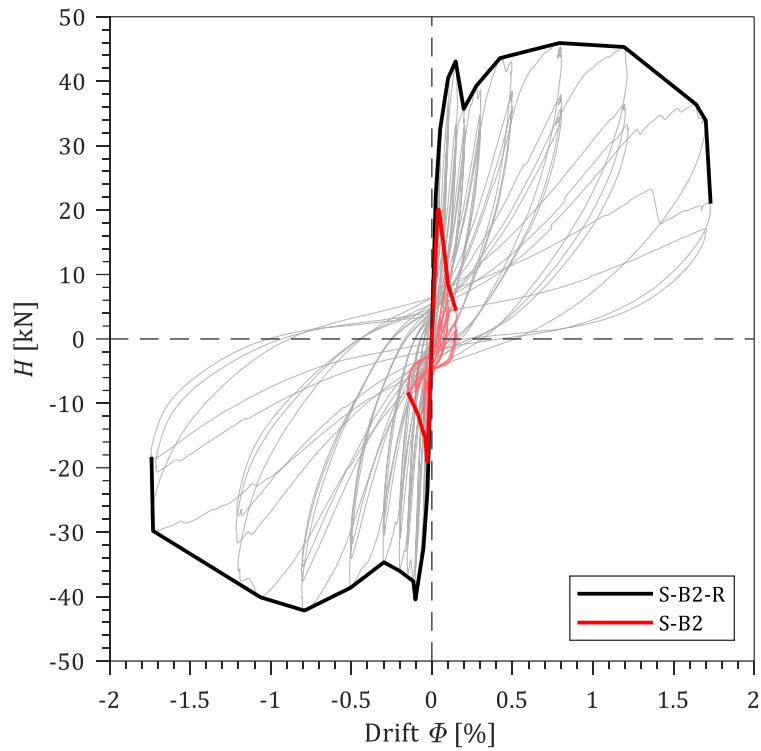
Fig. 133: Hysteretic curves and envelopes of unstrengthened and strengthened wall.

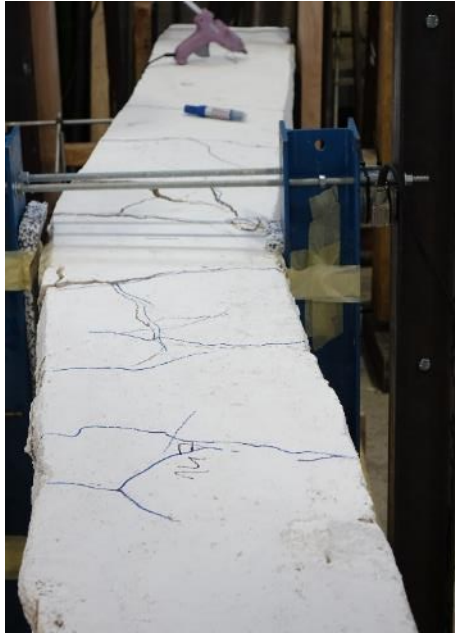
Fig. 143: Side view of T-R2 at collapse.
