THE EXPERIMENTAL CAMPAIGN AND NUMERICAL SIMULATIONS OF THE CONSTRAN PROJECT

TECHNICAL REPORT – PART 1

INTERPRETATION OF EXPERIMENTAL RESULTS

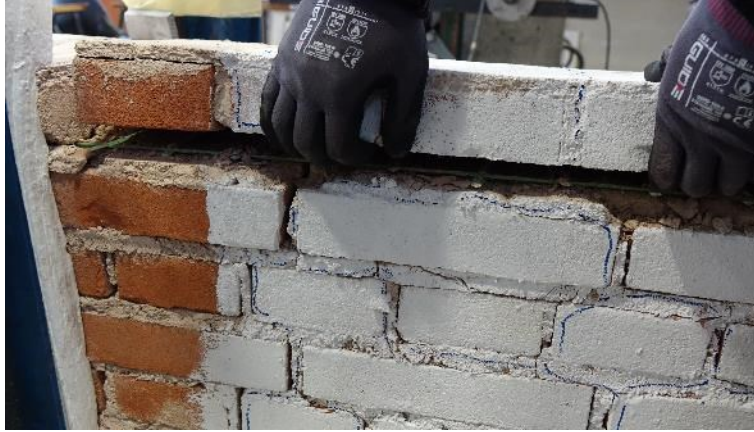
Fig. 149: Top row separated from the wall at collapse.

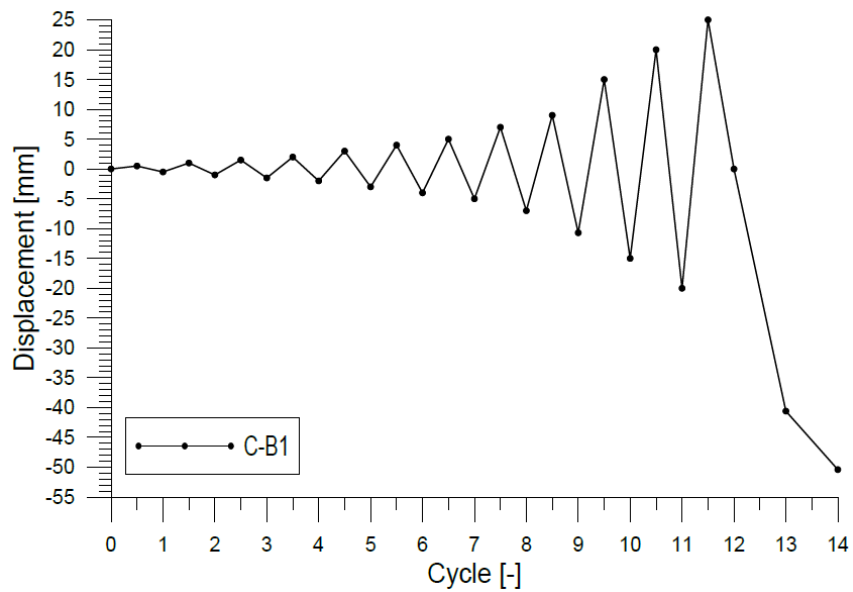
Fig. 158: Horizontal displacement sequence for specimen C-B1

A typical load protocol is shown in Fig. 158.

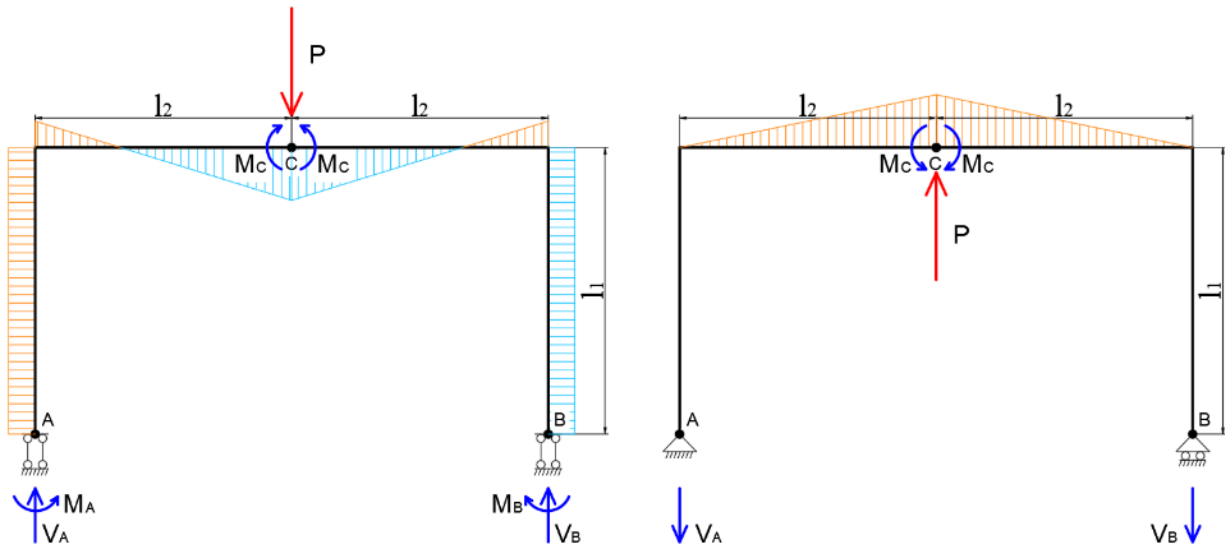
Fig. 159: Bending moment in the wall (uncracked elements) for negative (left) and positive direction (right)

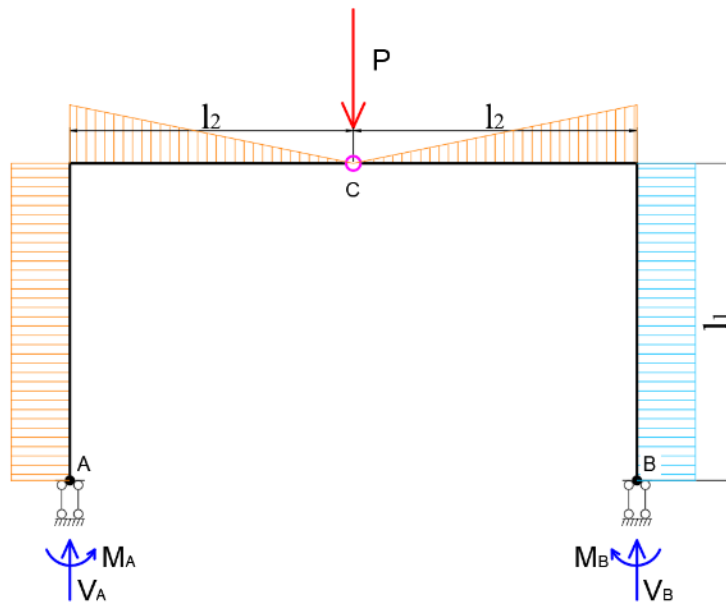
Fig. 160: Bending moment in the wall (cracked element) for negative direction

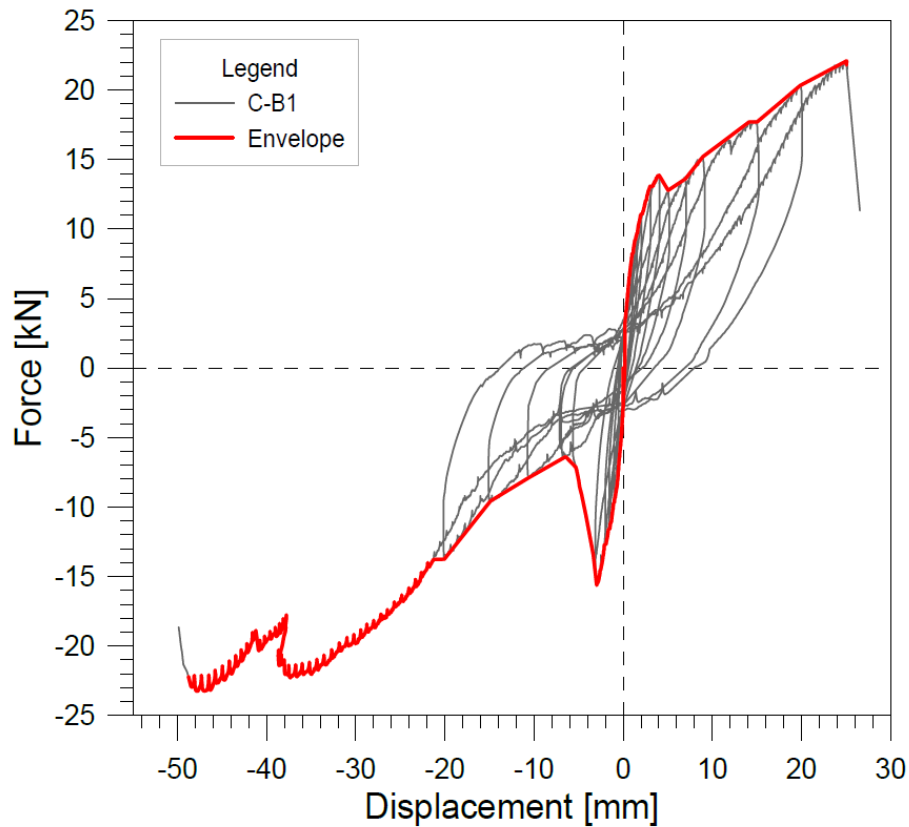
Fig. 163: Force vs out-of-plane displacement (*C_INT_AVG_REL*) curve and the envelope for sample C-B1

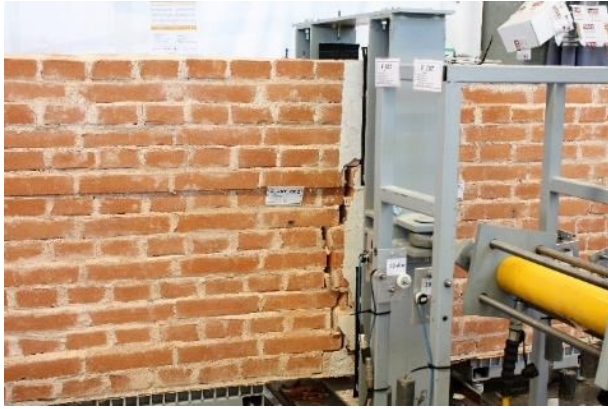
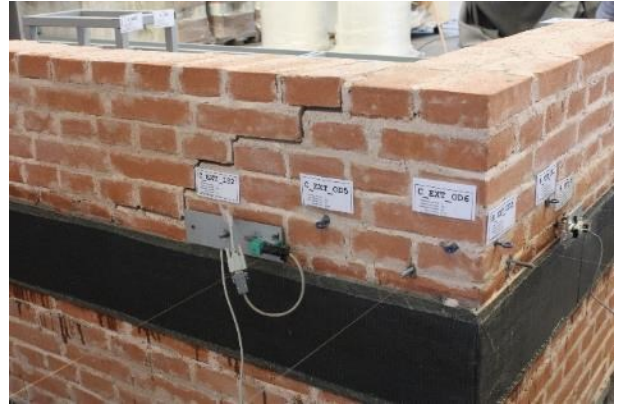
Fig. 166: crack configuration during the monotonic test – flexural cracks at step 12 (-40.6 mm)

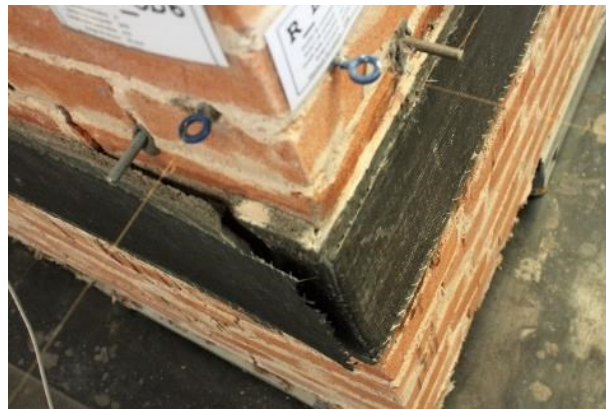
Fig. 167: failure of the CFRP strip in the right corner at -50.4 mm

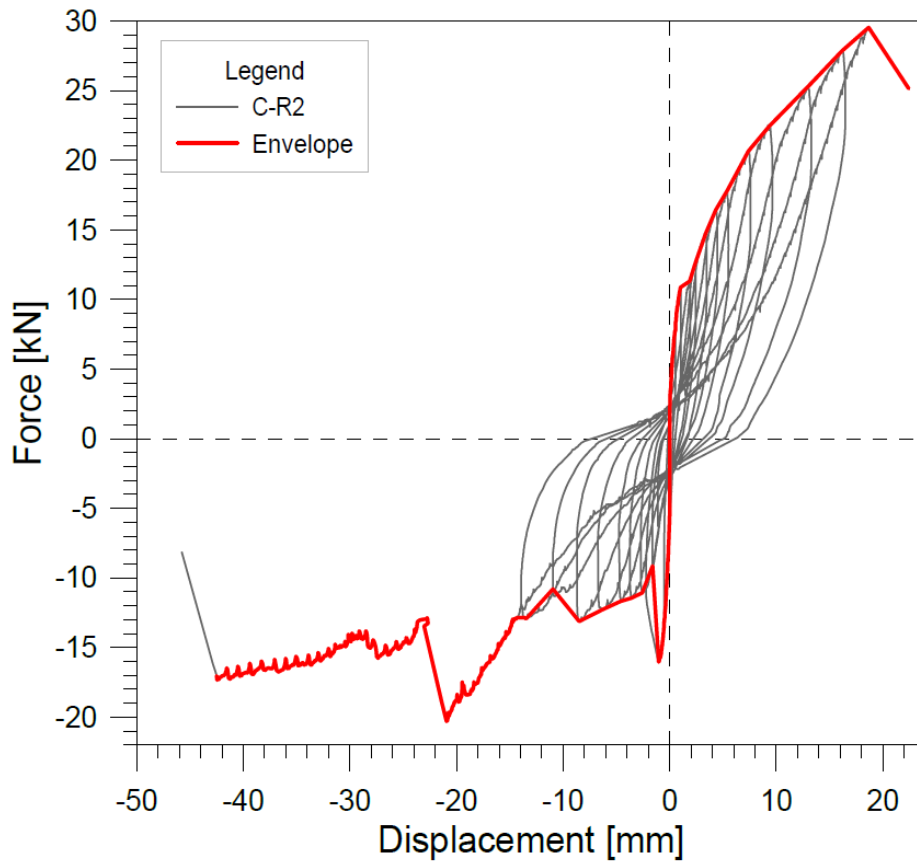
Fig. 169: Force vs out-of-plane displacement (*C_INT_AVG_REL*) curve and the envelope for sample C-R2

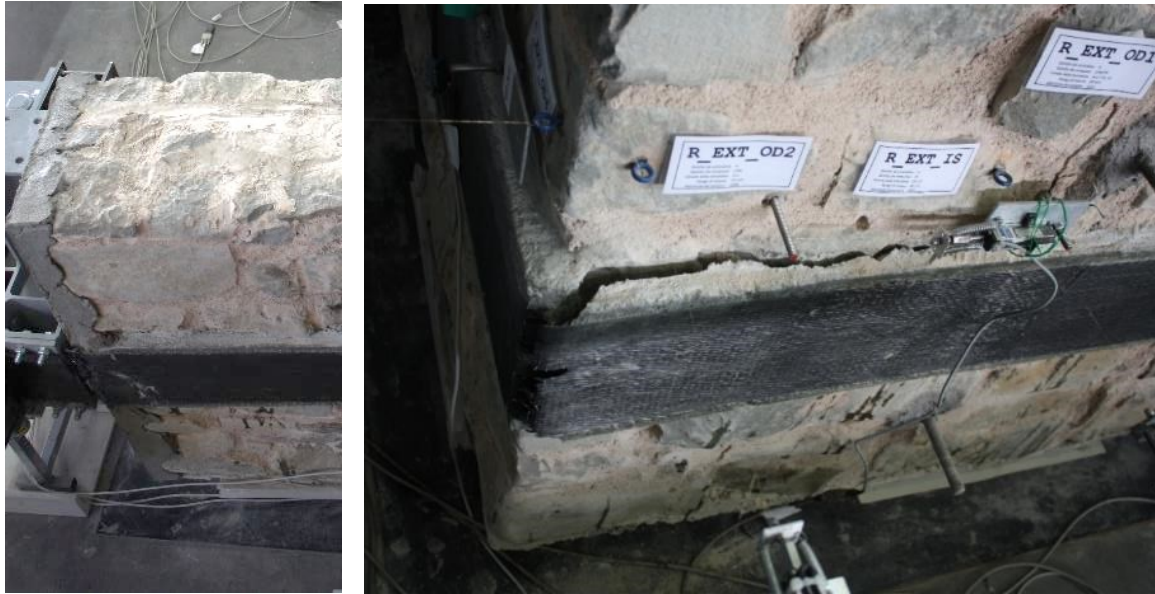
Fig. 172: (a) Detachment and partial breakage of the FRP strip from the masonry at the left support; (b) breakage of the CFRP strip in the right corner at -45.9 mm

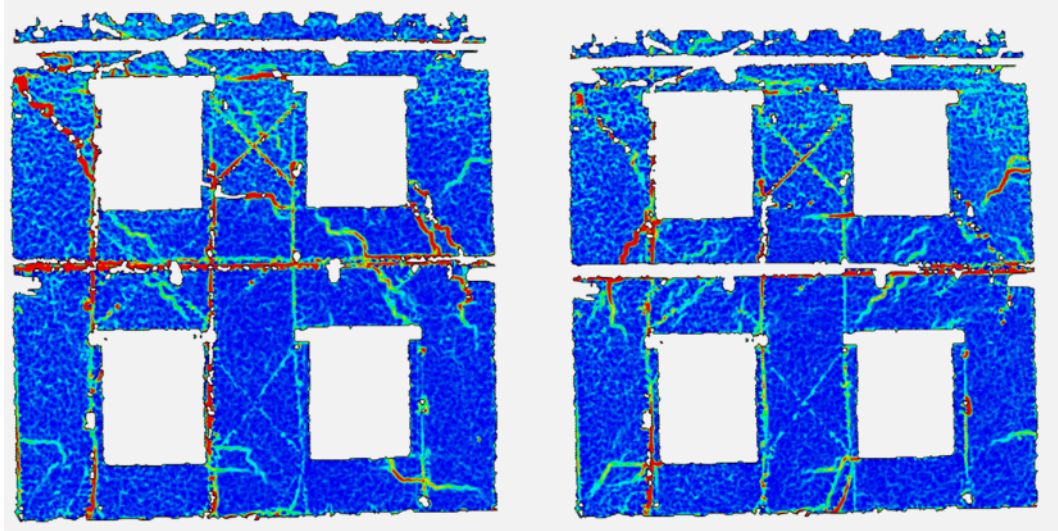
Fig. 182: Cracks on the East wall obtained by the DIC system. Red lines denote cracks. Damage when loaded in negative (left) and positive (right) directions.

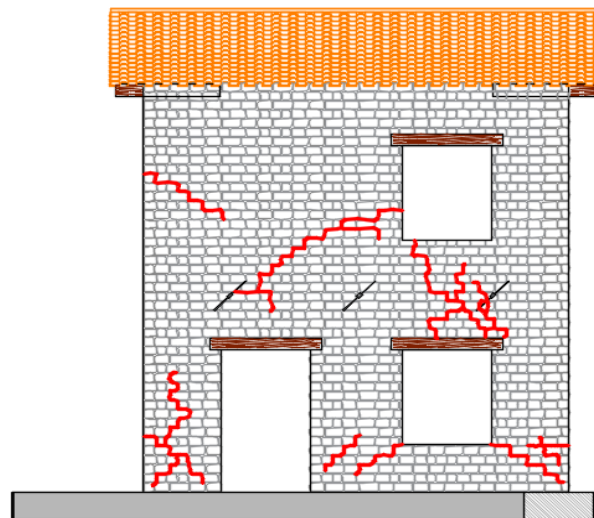
Fig. 183: Cracks on the West wall.

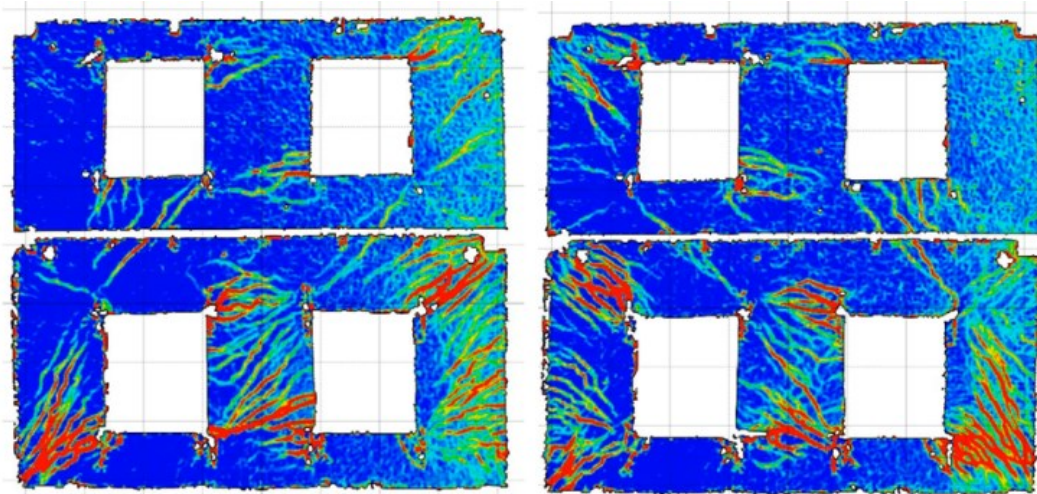
Fig. 185: Cracks on the East wall obtained by the DIC system. Red lines denote cracks. Damage when loaded in negative (left) and positive (right) directions.

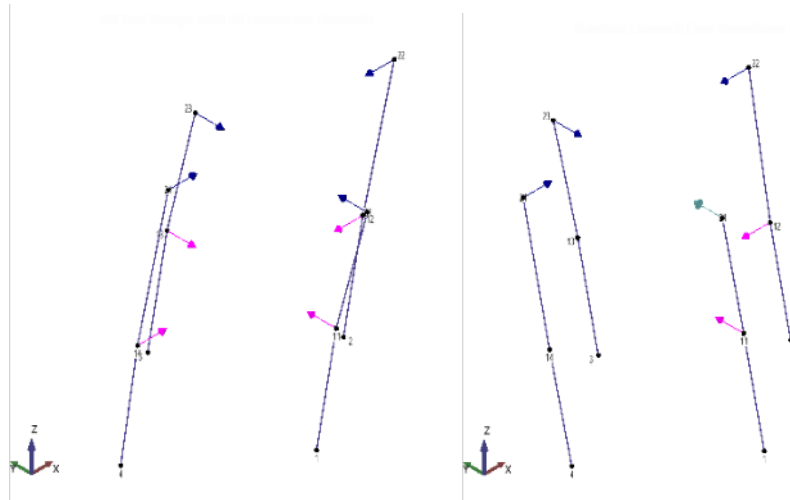
Fig. 187: The translational mode of vibration in X (left) and Y (right) directions.
