# PROBLEMS OF EXISTING MASONRY BUILDINGS AND COLLECTION OF STRENGTHENING TECHNIQUES AVAILABLE WITH DESCRIPTION OF THE APPLICATION

## TECHNICAL REPORT

### DEFINITION OF ADVANTAGES AND DISADVANTAGES OF TRADITIONAL AND MODERN STRENGTHENING TECHNIQUES, IN TERMS OF PERFORMANCE AND EXECUTION

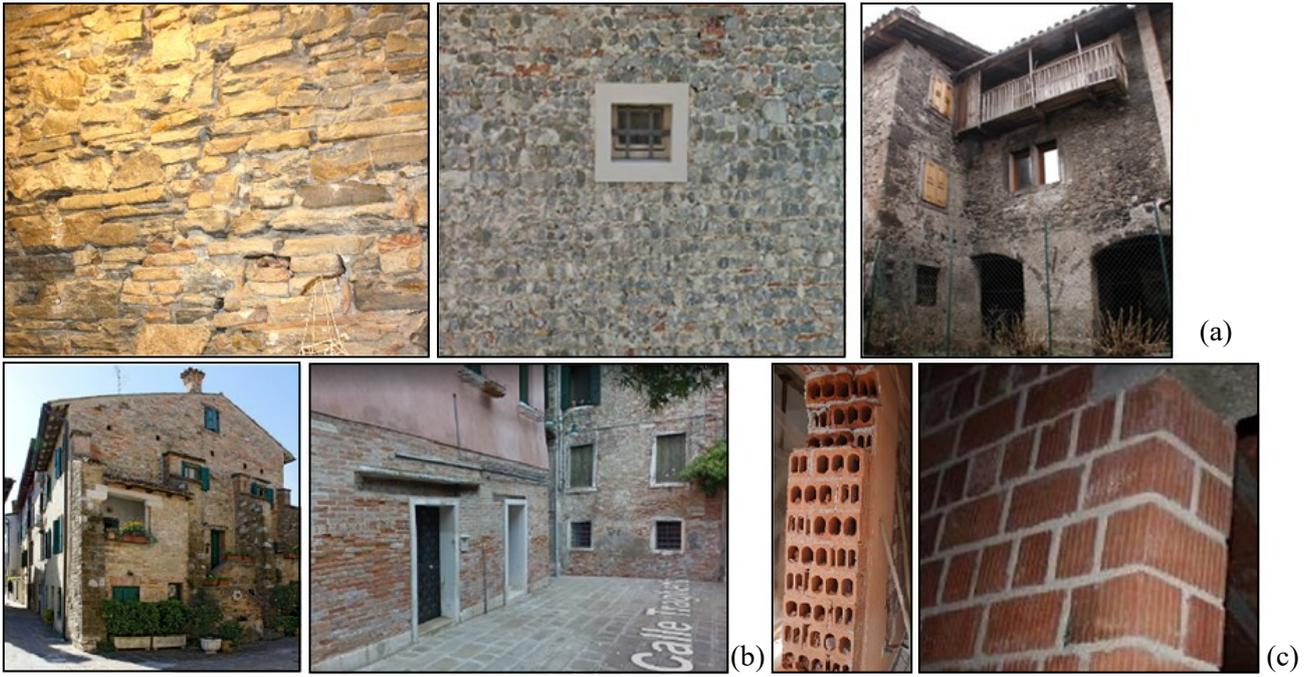
*Fig. 7: Masonry typologies in the Program area: stone (a), solid bricks (b) and hollow bricks (c).*

- Stone masonry buildings, both rubblestone and cobblestones (typical in traditional buildings of mountain/karst or river areas), with typical thickness 400-450 mm (+100÷150 mm every 2 storeys). In most cases, stone walls are multiple-wythe walls (two or more partially connected or not at all connected wythes);
- Solid brick masonry buildings (typical in traditional buildings of plain and coastal areas), with typical thickness 250-380 mm (+120 mm every 2 storeys). Sometimes, such walls are made with double wythes, which are adjacent but not connected or with a cavity in between;
- Hollow brick masonry buildings (age of construction mainly after 1950), with typical thickness 250-380 mm (+120 mm every 2 storeys). For this type also, there are single and double-wythe walls with a cavity between wythes.

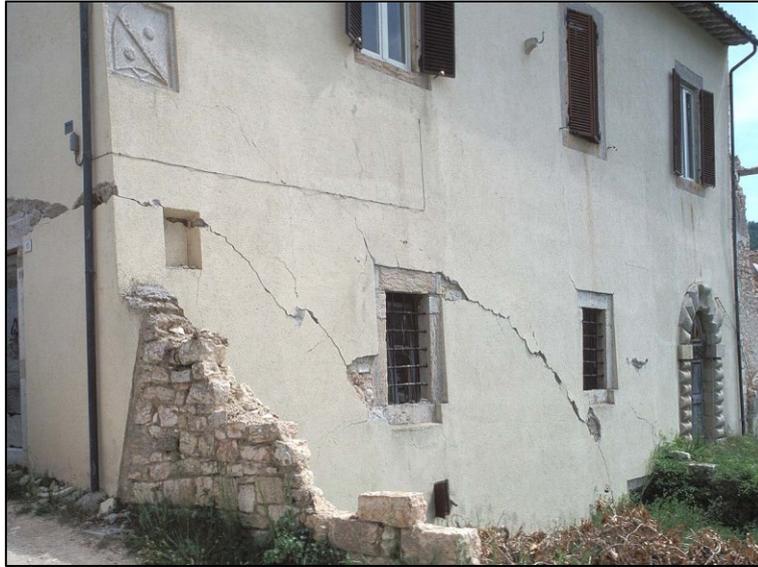
*Fig. 13: Diagonal shear damage (Umbria, 1997)*

The above-mentioned failure mechanisms for ancient masonry are well established and confirmed by post-earthquake damage observations. For newer types of masonry, literature sometimes mentions rocking as the fourth failure mechanism, but this is a response not failure mechanism, because the ultimate failure is normally bending failure with toe-crushing. In old masonry found in the Program area, diagonal shear failure is the most common failure mechanism observed after earthquakes. Typical diagonal cracking damage is shown in Fig. 13 and Fig. 14.

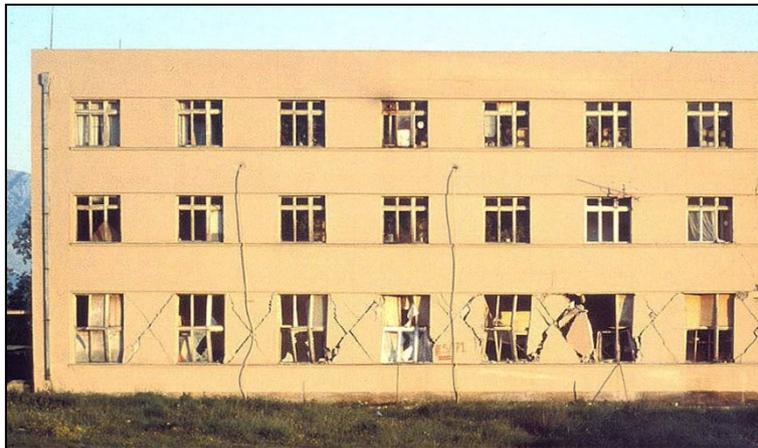
*Fig. 14: Typical diagonal shear damage in piers of ground storey (Budva, 1997)*

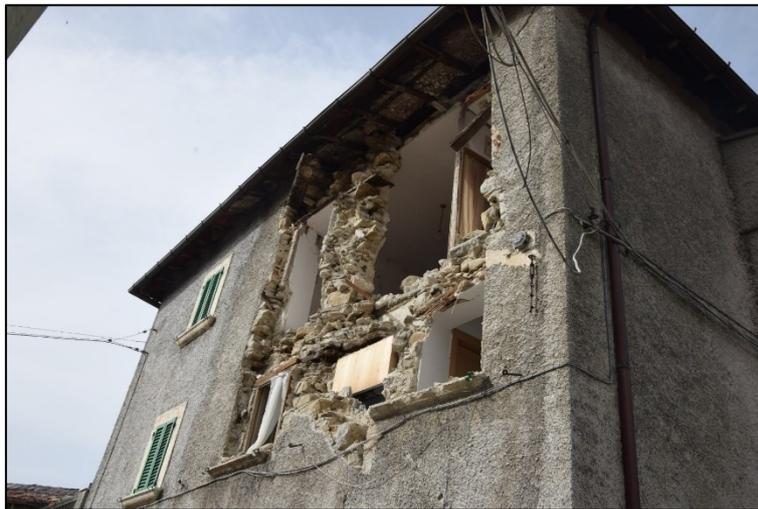
*Fig. 16. Out-of-plane failure of a two-wythe wall (Borgo, 2016).*

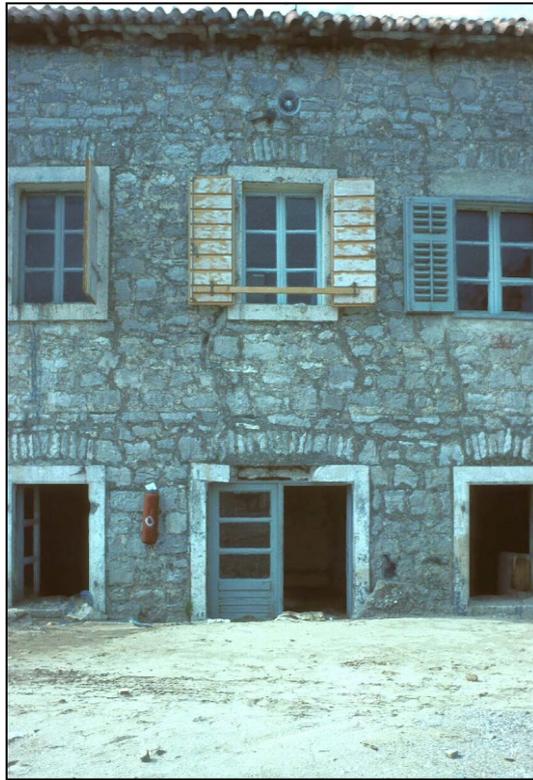
Fig. 17: Building sank 1m into liquefied soil.

Finally, even if the masonry building has structural integrity and proper distribution of strong walls, *the ground under the building can still fail*. The building in Fig. 17 sank about a meter into the soil that liquefied due to the dynamic excitation, because of its properties. That could happen also in case of landslides (as shown in Fig. 18). There are many vulnerabilities to consider.

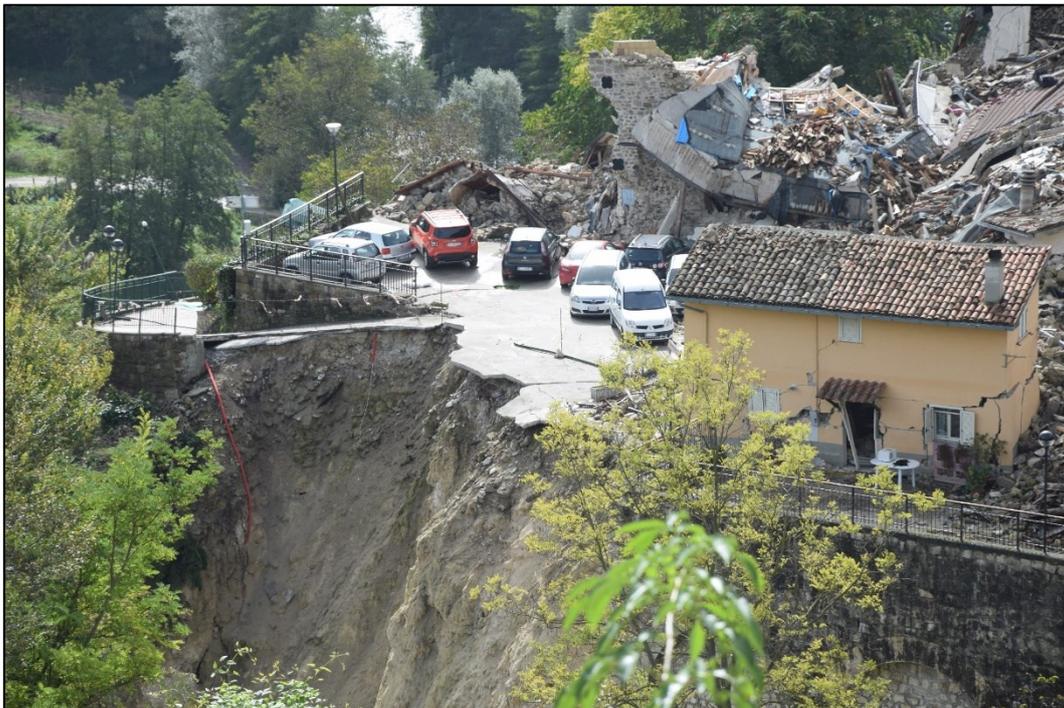
Fig. 18: Buildings cannot resist landslides (Arquata, 2016).

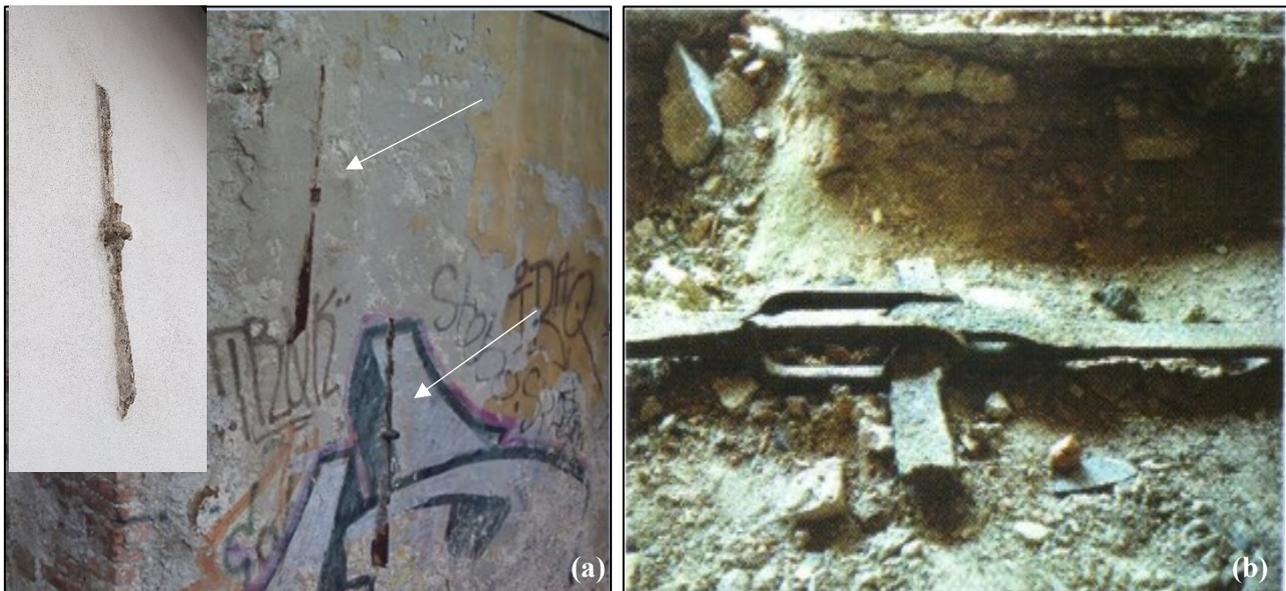
Fig. 19: Anchors of steel ties on the façade (a), iron tie from XVII century house in Ljubljana (from Tomažević, 2009) (b).

If the considered building does not have ties connecting all walls at the level of floor structures, the providing of ties *should be the first step of any strengthening intervention*. It is relatively easy to find out if ties exist in a building or not. The anchors of wall ties are frequently visible on the façade (Fig. 19a), otherwise they can be located by metal a detector or a geo-radar (Fig. 19b).

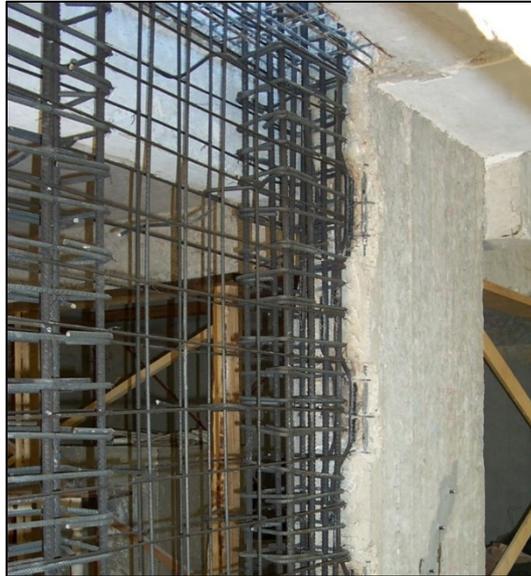
Fig. 20: Adding walls to an existing structure<sup>4</sup>.

Measures for improving structural layouts usually consist of adding new walls. For large structures, the new walls are often RC walls with new foundations (Fig. 20). It is also possible to add new walls or close some openings in existing walls. The aim of these interventions is to achieve a similar amount of masonry (walls) in both perpendicular directions, and to have a layout of walls in which the centre of mass and centre of rigidity (in a floor) are as close as possible.

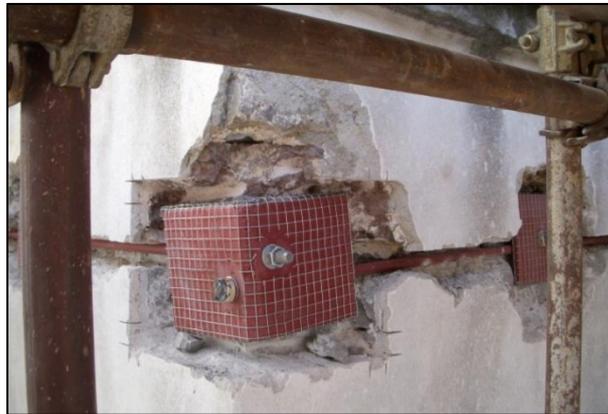
*Fig. 22: Ties and steel anchor plates at the corner.*

The traditional approach of tying walls together is to use steel ties and to anchor them using steel plates ([Fig. 22](#)). Ties are usually provided for each wall and are usually installed in specially cut grooves. The location of the ties in height is as close as possible to the floors. In practice this is usually just beneath the floors. The diameter of the steel ties is normally 16-20 mm, but is determined by calculation (a tie must be at least as strong as the wall it ties). Ties are installed for all walls (perimeter and inner walls), as it can be clearly seen in [Fig. 23](#). The ties are usually lightly prestressed by tightening the nuts with a wrench. This very effective technique is in use in Slovenia since late 70s.

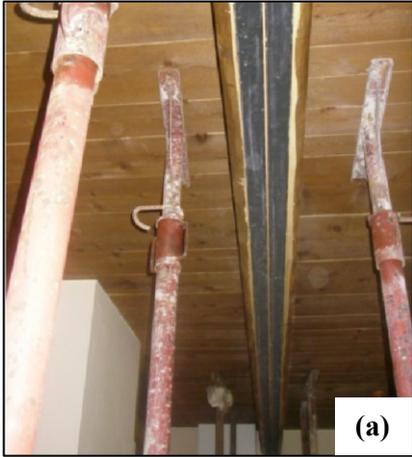
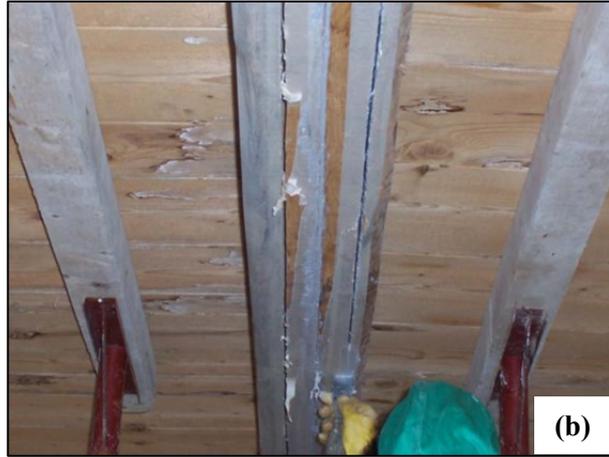
*Fig. 35: Propped ceiling joists strengthened by carbon fibre strips.*

Wooden beams can be strengthened by using FRP or steel strips on the lower surface of the beams. Many layouts of the strips can be used. FRP strips can be glued to the beam by epoxy resin, and steel strips can be glued or nailed to the beam. The possible layouts are shown in Fig. 33 and Fig. 34. It is important to prop the beams before applying the strengthening. The propping can also be used to repair sagging (Fig. 35).

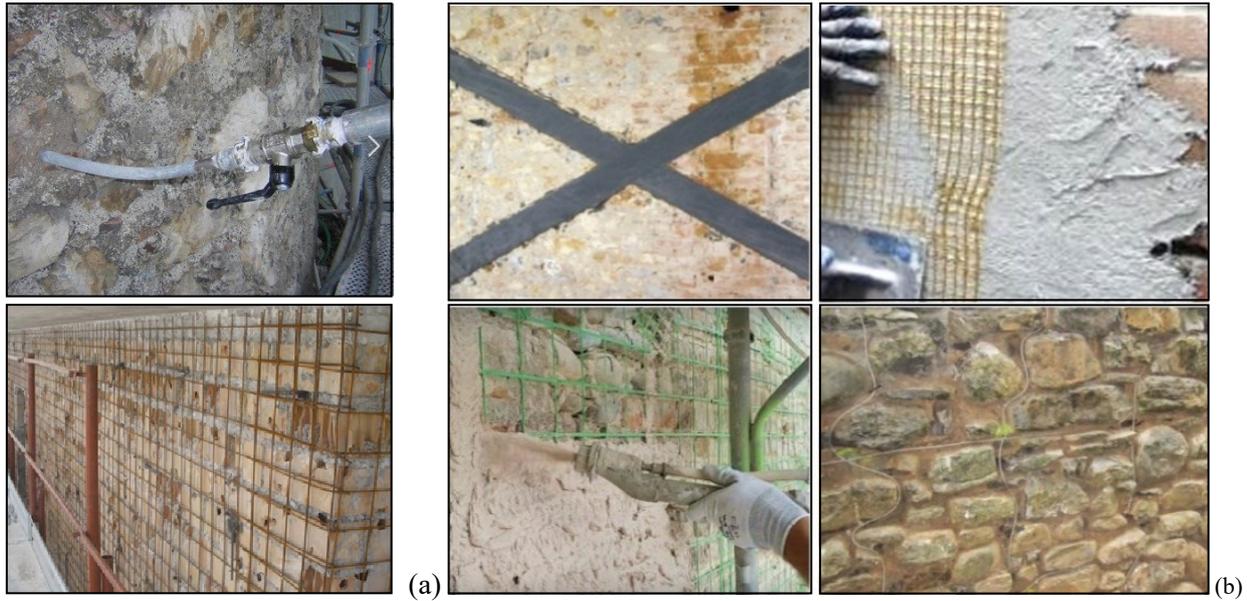
Fig. 37: Strengthening of existing masonry performances. Traditional grouting and RC coating (a). Modern techniques (b) Clockwise from top left: CFRP glued strips, Fibre Reinforced Cementitious Matrix (FRCM), repointing with steel strands and preformed GFRP mesh embedded in lime mortar.

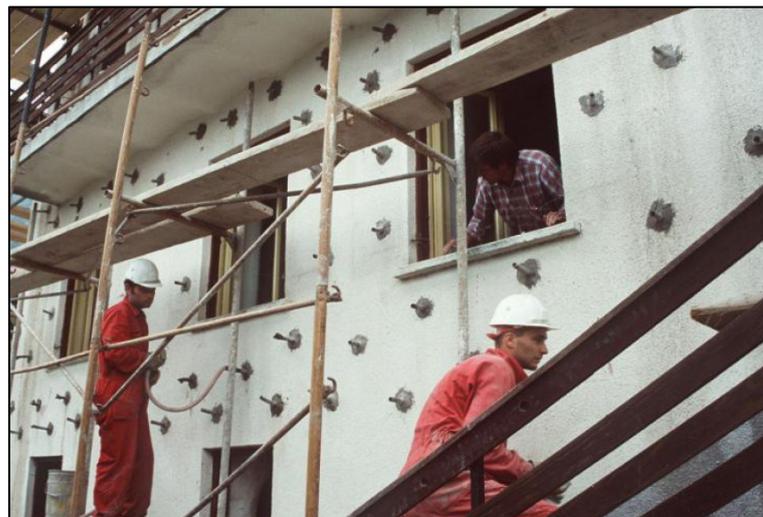
Fig. 39: Injecting stone masonry in practice<sup>5</sup>.

The process of grout injections consists of the injection through flexible plastic pipes with a nozzle, of a highly fluid, high strength binder mixture, with a low water to binder ratio. Before injections of the joints among the bricks or stones, cracks and discontinuities have to be sealed. To avoid leakage, the injection has to be provided slowly and at low pressure. The injections are performed in several lifts. A lift is completed when the grout appears in the pipes of the next lift ([Fig. 38](#)). Indicative consumption of grout is between 50 and 150 kg/m<sup>3</sup>, but varies greatly with the type of masonry. The density of pipes for injections in practice is shown in [Fig. 39](#).

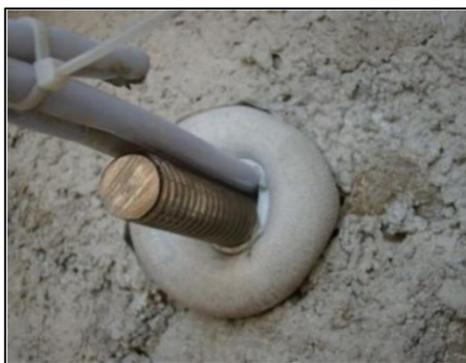
(a)

Fig. 42: Visible part of the artificial diaton after installation<sup>6</sup> (a), side view of the inserted diaton (b).

The artificial diatons consist of stainless-steel bars enclosed in a mesh fabric sleeve, which contains the special grout that is injected after the diaton is inserted into the wall. The first step of the procedure is to drill a hole through the wall, insert the diaton and inject the sleeve with grout. An artificial diaton is shown in Fig. 41. The head of the diaton after installation is shown in Fig. 42a, while Fig. 42b shows the fabric mesh for grout and how it expands to fill the area between the stones.

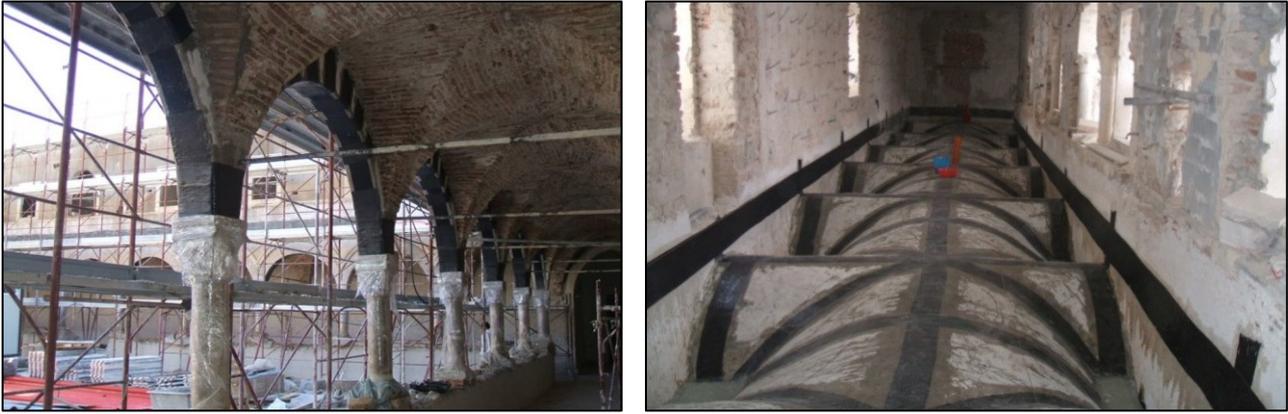
Fig. 43: Externally bonded FRP strips in arches (left) and vaults (right).

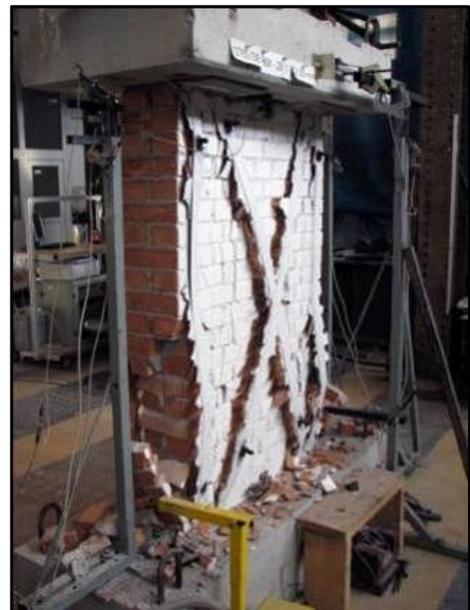
Fig. 44: Strengthening walls with FRP strips (Gams et al. 2017)

Prior to gluing the strips to masonry by epoxy glue, the surface of the masonry needs to be appositely prepared. Usually this involves sandblasting and using a primer to strengthen the surface. Nevertheless, some tests show that bond can fail and that such procedure is not sufficient. If the wall shrinks due to compression, the strips are likely to buckle out of plane and lose the bond with the wall. Since additional compressive stresses causing shrinkage are common during earthquakes, the application to walls may not be the most appropriate.

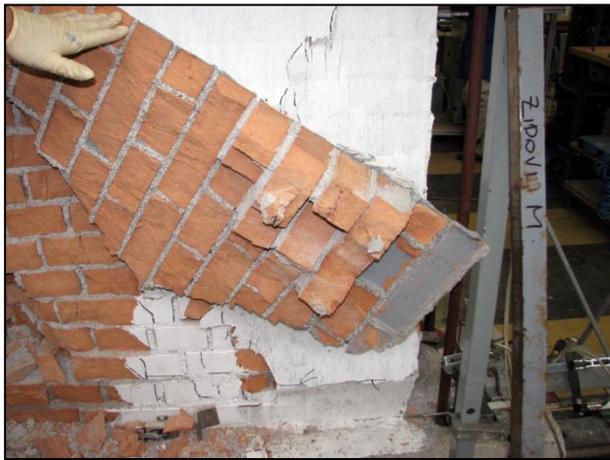
Fig. 46: Peeling off of type of debonding between coating with an epoxy matrix, left. Hysteretic response of walls with one sided and two sided GRPF reinforced coating in epoxy matrix, right (Gams et al. 2017).

When the FRPs had started to be used to strengthen masonry, FRPs were often glued to walls by epoxy resin. However, tests soon revealed that the incompatibility between a very strong epoxy resin compared to weak historic masonry caused problems. The key problem was that the difference between materials causes large stress concentrations at the bond and it tended to fail at quite low loads. Typically, the failure starts with the peeling off of a thin layer of masonry, as shown in Fig. 46, left. The improvement in seismic performance of such strengthening technique, shown in Fig. 46 right, does not justify its cost.

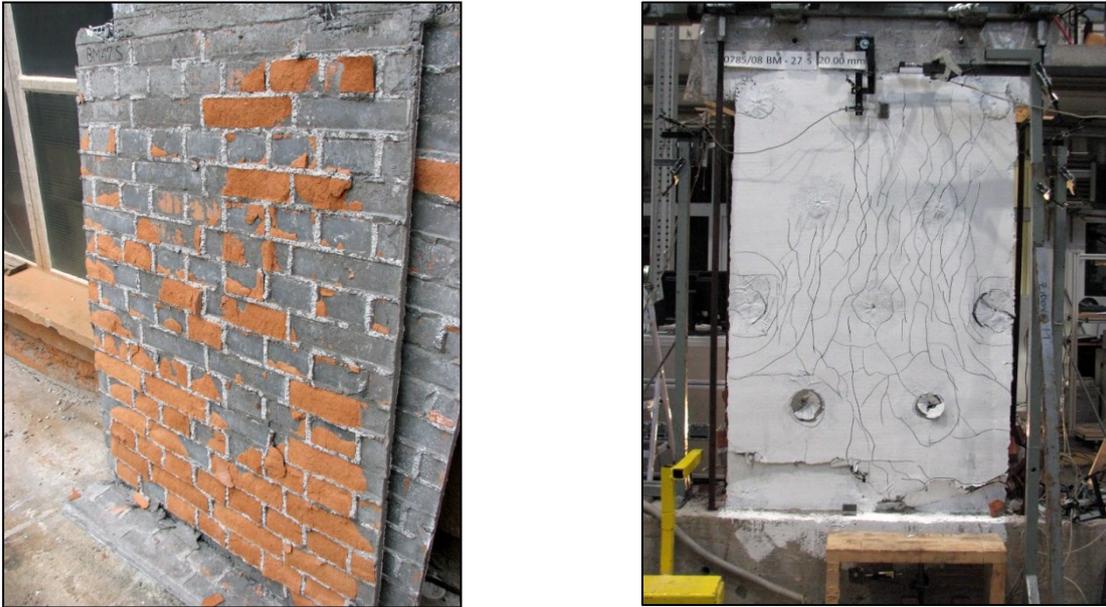
*Fig. 56: Completely separated coating without anchors (a). Failure of bond and anchors in case of highest density of anchors (b)*

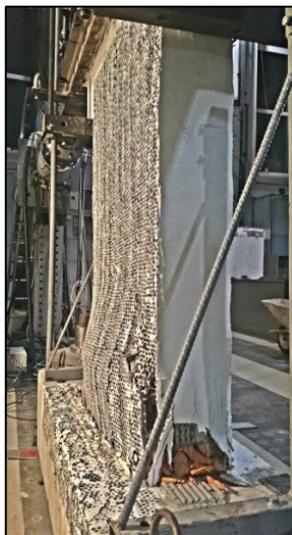
Fig. 60: Buckling of the coating, left. Envelopes of the hysteretic response of two reference walls (red) and two strengthened walls (blue), right.

Two reference and two strengthened walls were tested in shear-compression. The coating debonded and buckled (Fig. 60, left) but continued to support the wall because the GFRP was wrapped around the wall. Resistance of the wall increased by over 50 % due to strengthening. The displacement capacity was increased by a factor of 3.4 (Fig. 60, right).

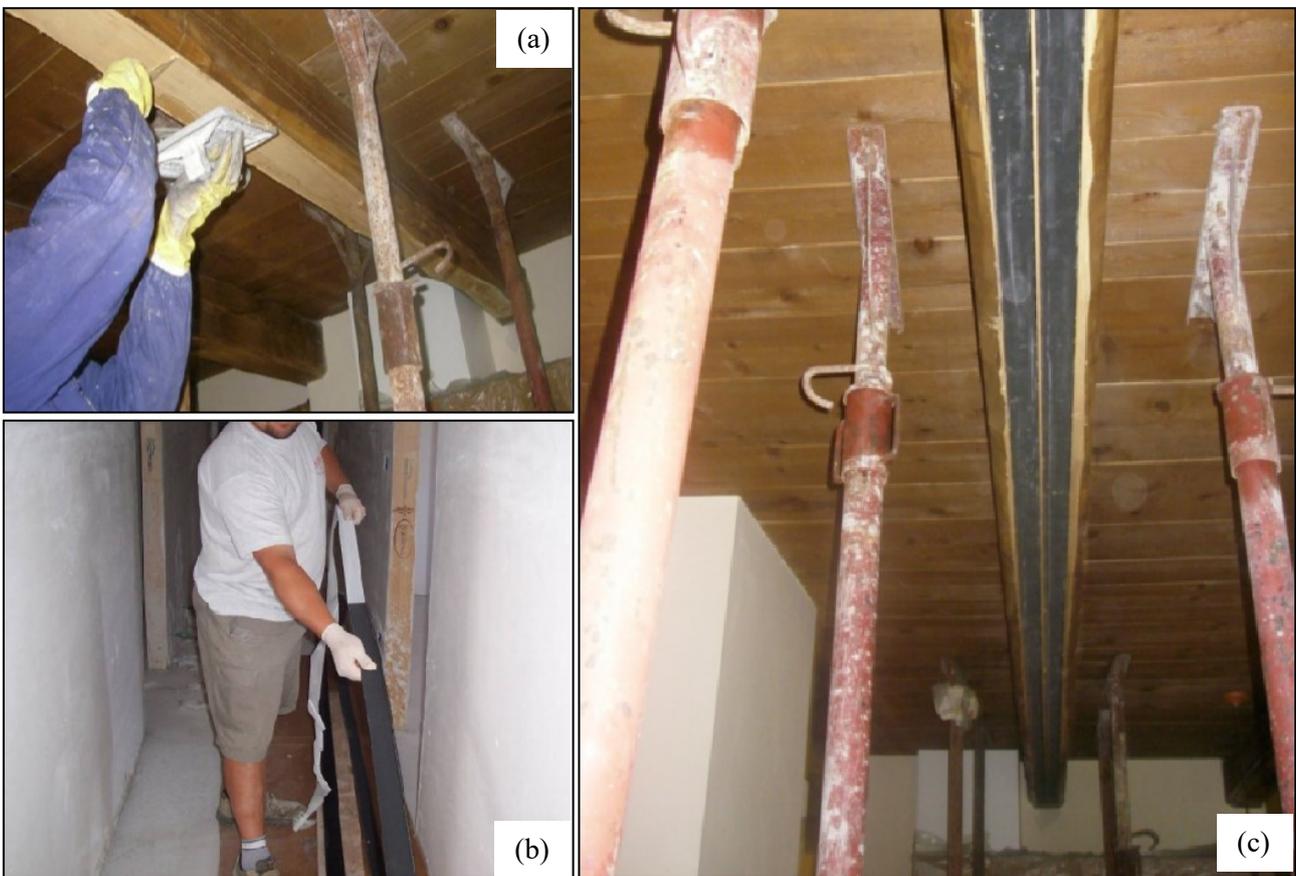
*Fig. 64: Wooden beam strengthening with the use of an FRP pultruded sheet: applying of a special thixotropic epoxy resin in the beam groove (a); peeling of the dust protection ply from the FRP plate (b), positioning of the pultruded sheet (c)*

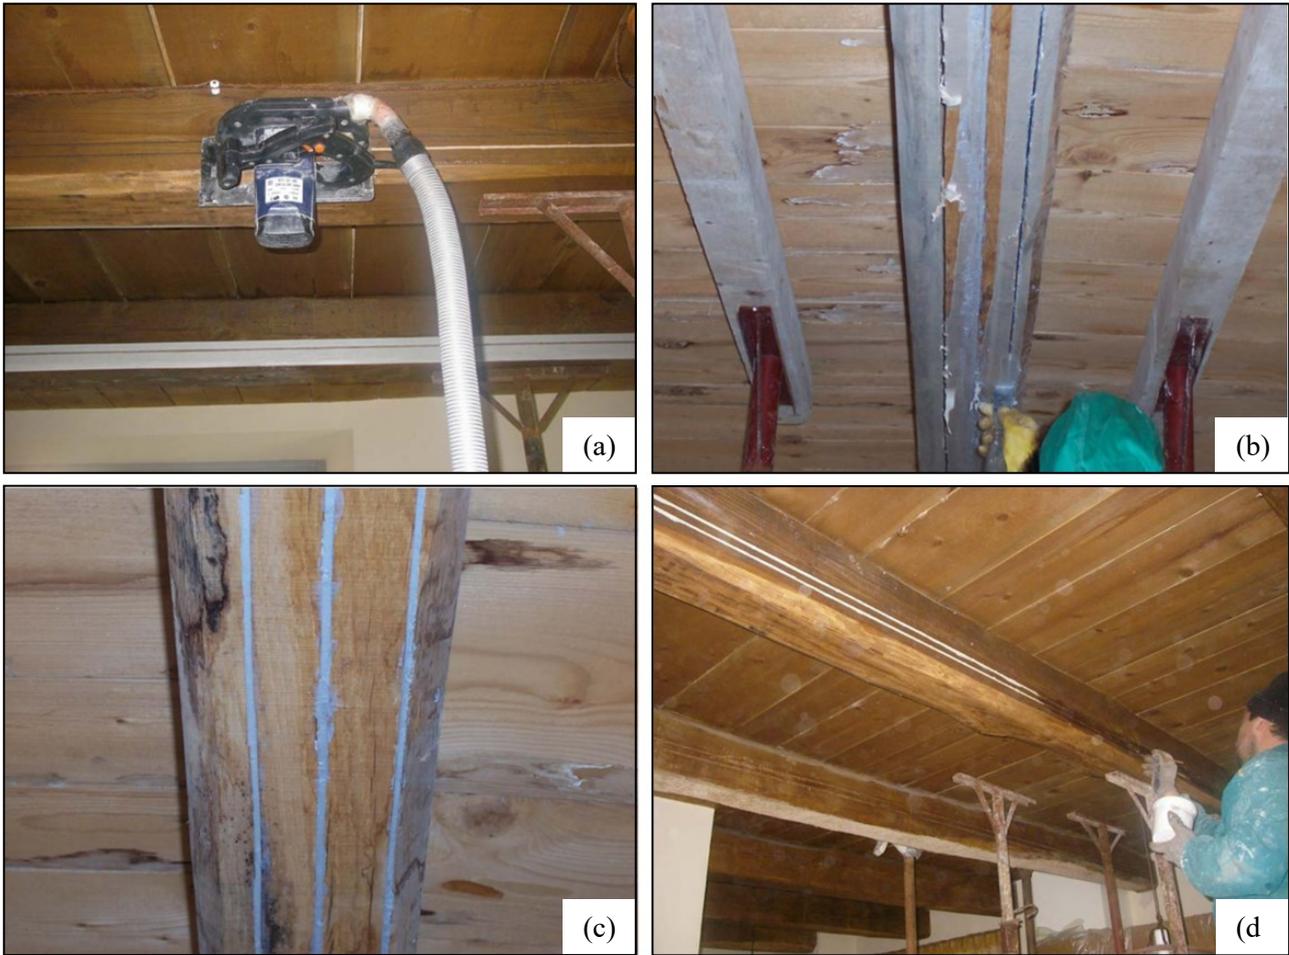
Fig. 65: Intervention through FRP sheets: carving the notches with a wood cutter (a), manual removal of the excess resin (b), positioning of the sheets (c and d)

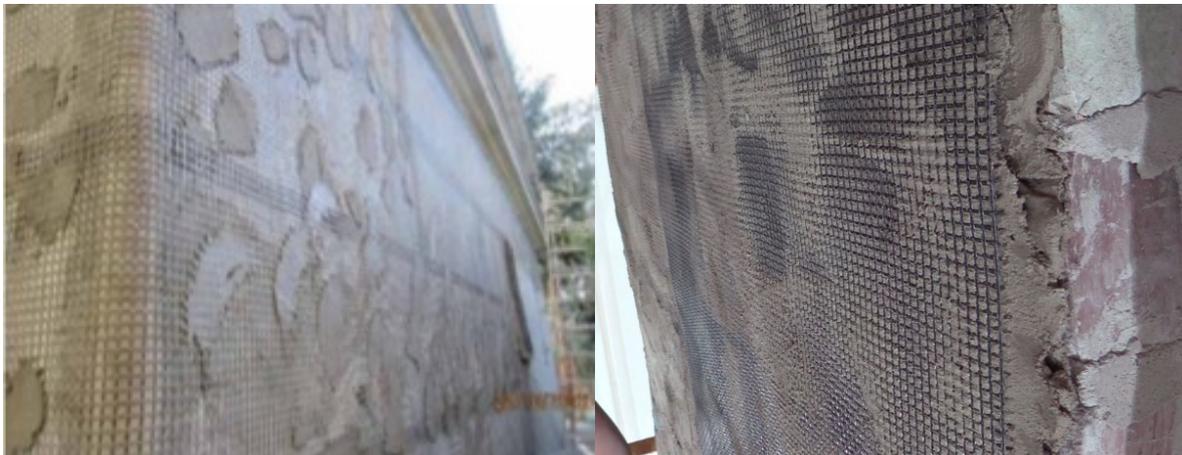
*Fig. 72: Strengthening technique: FRCM system*
