NANO-REGION

PROOF-OF-CONCEPT EXPERIMENT REPORT

INVESTIGATION ON FAILURE WITH COMMERCIAL CHIPS BASED ANALYSIS

Istituto Officina dei Materiali - CNR-IOM

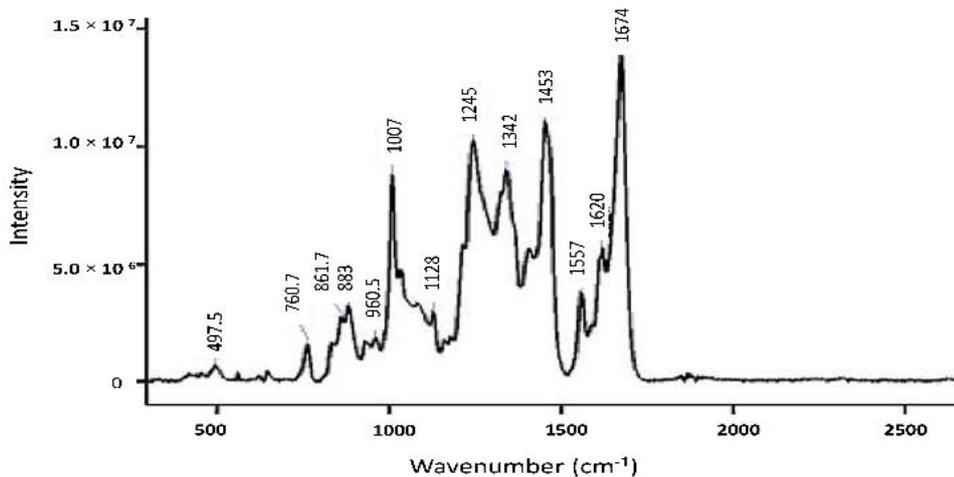
Figure 7 shows a typical Raman spectrum of Antibody.

All the signals are in the range from 700 cm^{-1} to 1670 cm^{-1} . No features associated to Ab have been recognized in the spectra.
